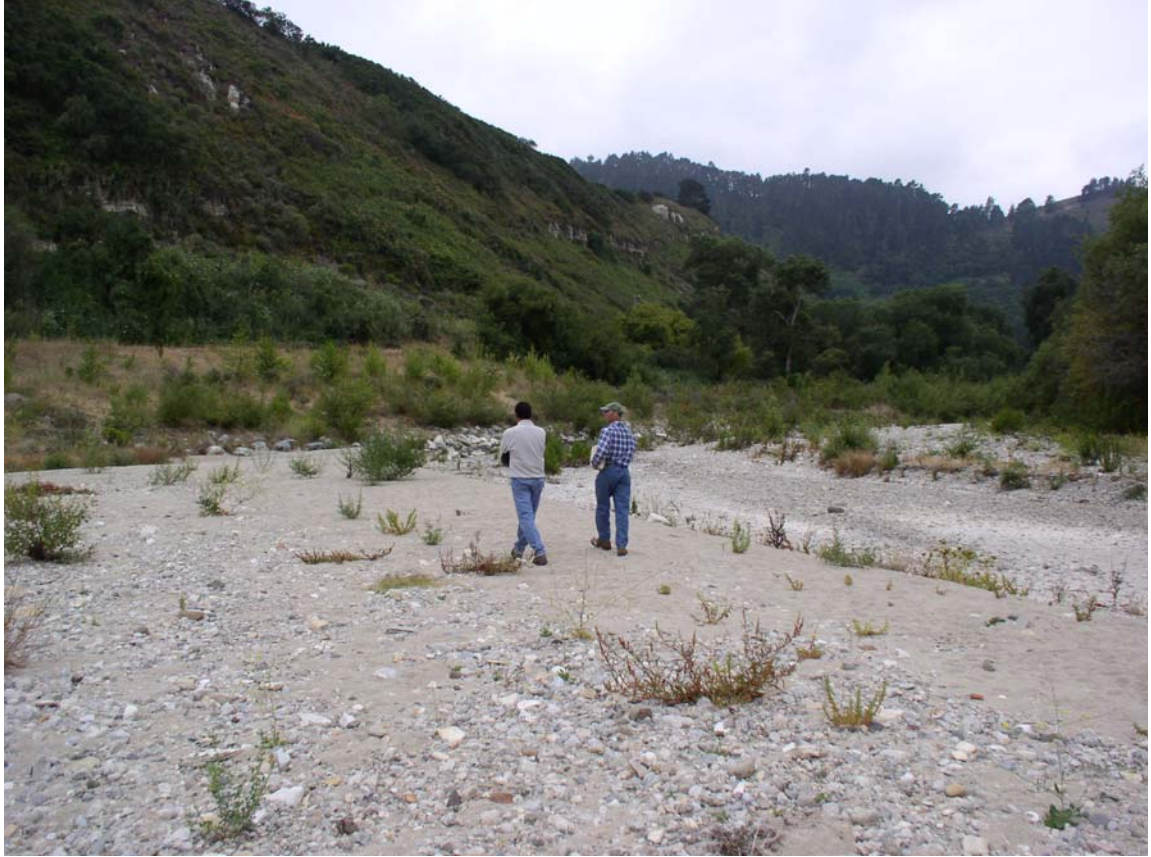
Primary riparian vegetation includes: black cottonwood, red and arroyo willow, white alder, and western sycamore. This reach is constrained on the north bank because of Rancho Cañada’s Golf Course’s rip-rap installation, designed to protect against streambank erosion. The south bank also contains rip-rap associated with Rancho San Carlos’ restoration project. There are limited opportunities for large wood recruitment from the north bank because trees are still young. Riparian vegetation in this reach is vulnerable to impacts from groundwater extraction from Cal-Am’s Cañada Well. However, supplemental irrigation occurs on the north and south bank to mitigate the groundwater extraction.
