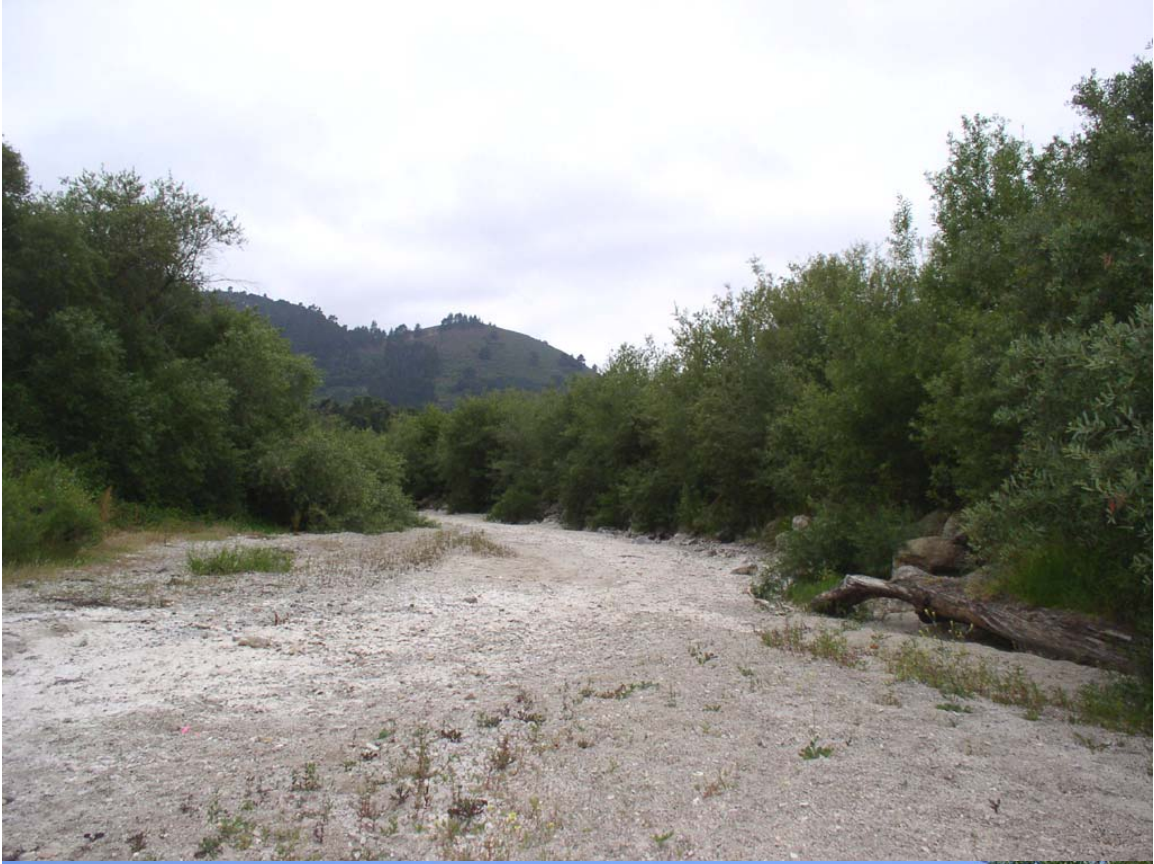
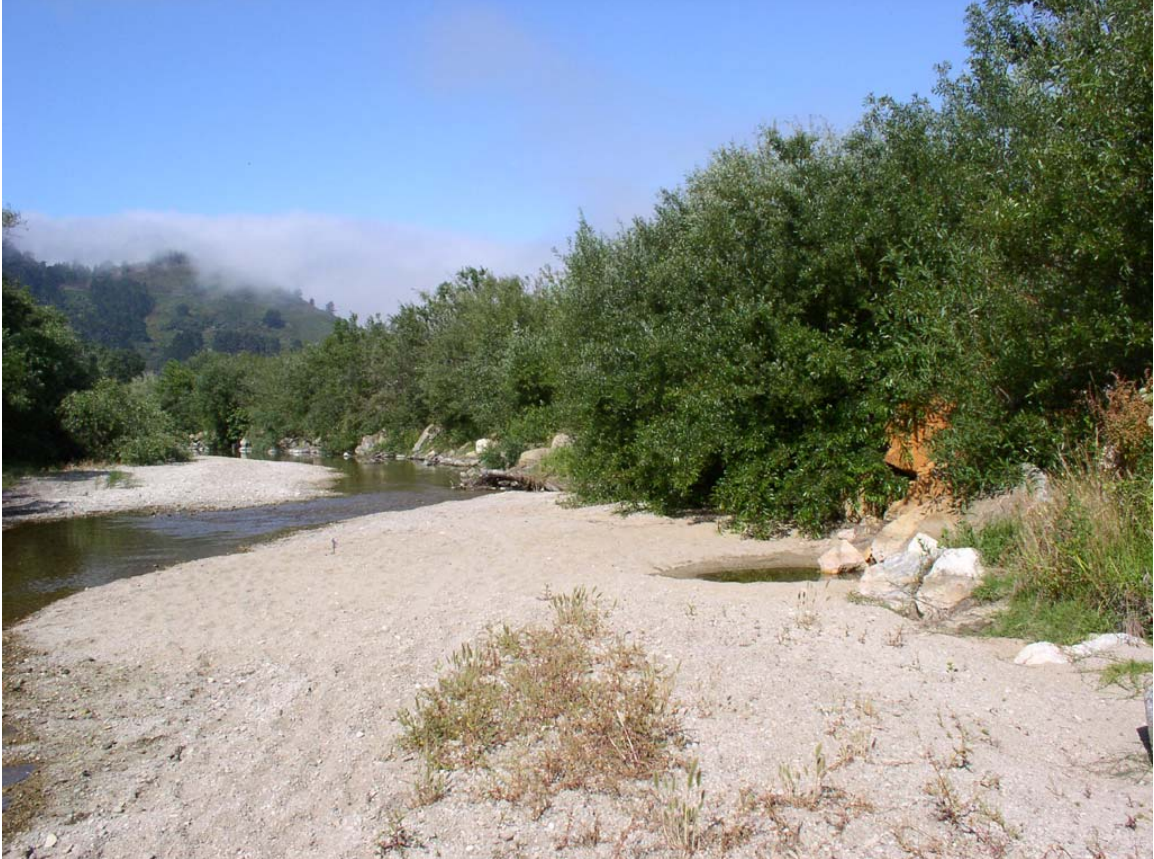
Primary riparian vegetation includes: black cottonwood, red and arroyo willow, white alder, and western sycamore. This reach is constrained on the north bank because of Rancho Cañada’s Golf Course’s rip-rap installation, designed to protect against streambank erosion. Riparian vegetation is developing nicely on this bank stabilization project. There are limited opportunities for large wood recruitment from the north bank because trees are still young. Riparian vegetation in this reach is vulnerable to impacts from groundwater extraction from Cal-Am’s Cañada production well. However, supplemental irrigation occurs on the north and south bank to mitigate the groundwater extraction.
