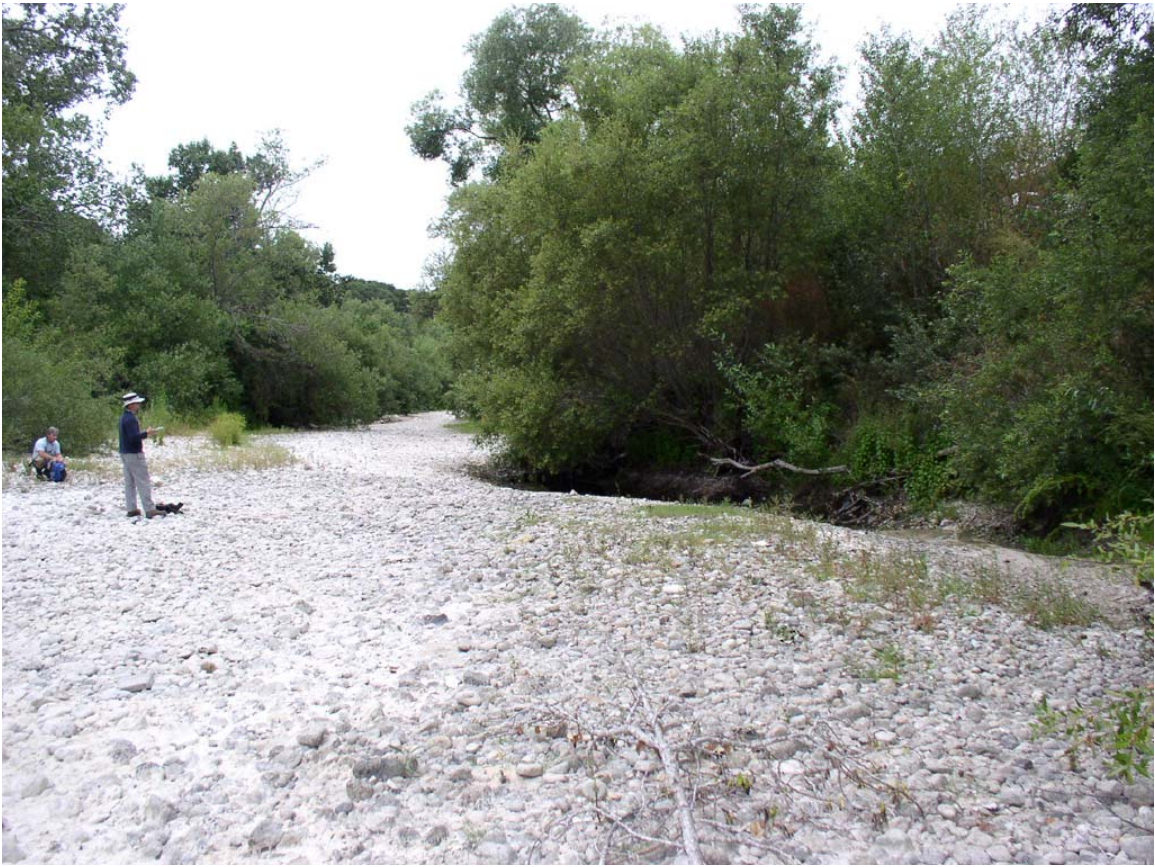
The riverbank by the Quail Lodge Maintenance Building parking lot is susceptible to erosion and currently is only protected by a few riparian trees. Rip-rap in this area has impacted the natural sinuosity. This area is also impacted by groundwater withdrawal from Cal-Am's Cypress Well.

Proper Functioning Condition	_____
Functional – At Risk	<u> X </u>
Nonfunctional	_____
Unknown	_____

Upward	_____
Downward	_____
Not Apparent	<u> X </u>
