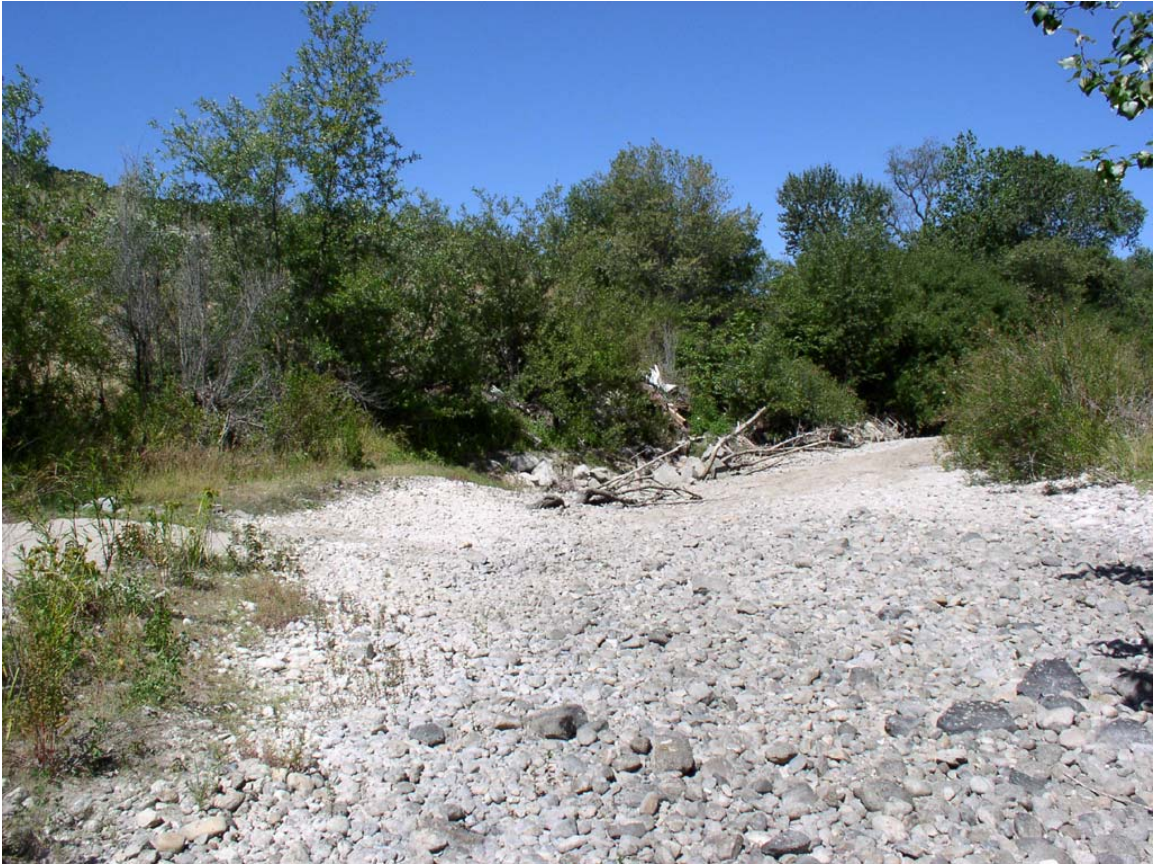
Primary riparian vegetation includes: black cottonwoods, red and arroyo willows, white alders, and western sycamore. This section received a functional at risk rating because there was a thin band of riparian vegetation associated with old cars as structural bank protection that could fail in a high flow.

This area is also impacted by groundwater extraction by Cal-Am's Cypress Well.
