Standard Checklist

Name of Riparian -- Wetland Area: Carmel River Watershed -- Schulte Bridge Area

Date: 6/25/04		Segment/Reach ID: 11-Carmel River 100 yards upstream of Shulte				
		Bridge				
Miles:	Acres:	Coordinates:	Begin	5727801 E	2087659 N	
			End	5735604 E	2083951 N	
ID Team Observers: Thomas Christensen and Larry Hampson

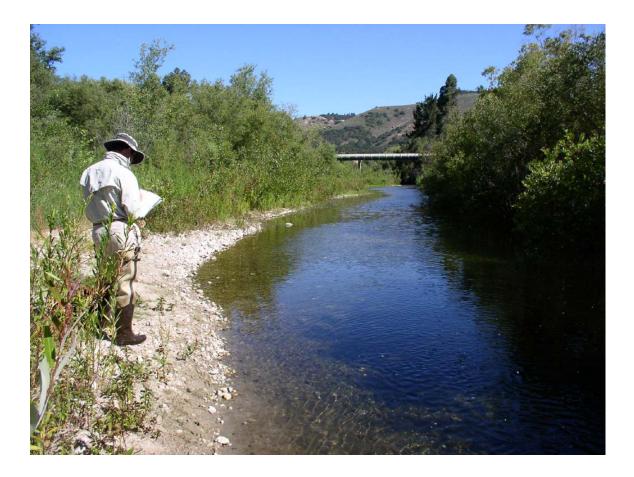
Primary riparian vegetation includes: black cottonwoods, red and arroyo willows, white alders, and western sycamore. This particular reach was part of a MPWMD restoration project in 1987.
