## Standard Checklist

Name of Riparian – Wetland Area: Carmel River Watershed – Carmel Valley Ranch Area

Date: 6/8/04 Segment/Reach ID: 13-Carmel River at Carmel Valley Ranch Golf Course

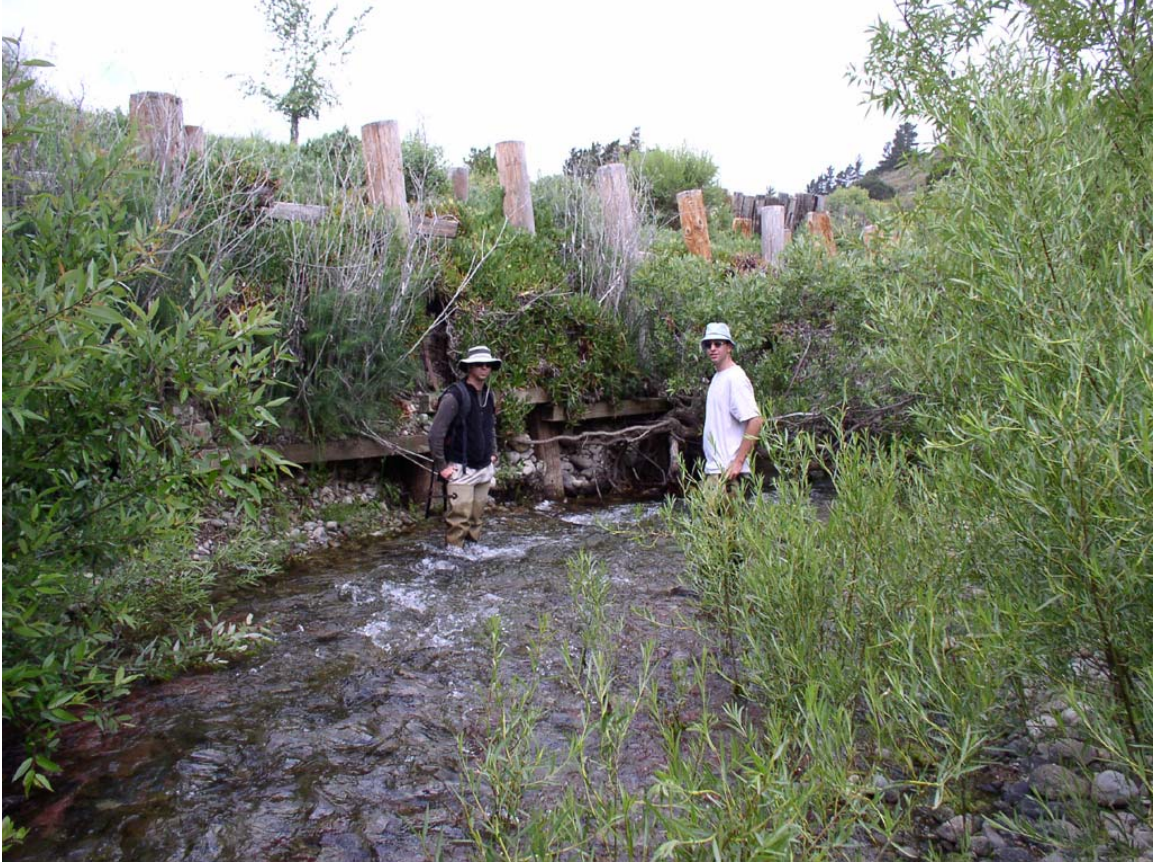
Primary riparian vegetation includes: black cottonwood, red and arroyo willow, white alder, and western sycamore. This reach is constrained on the south bank because of Carmel Valley Golf Course's post and wire installation, which was originally designed to protect against streambank erosion. Post and wire supports are exposed and active bank cutting in and under the posts is occurring. In addition, Cal-Am's Scarlett well may dewater this area in a dry year.

<input type="checkbox"/> Flow regulations	<input type="checkbox"/> Mining activities	<input type="checkbox"/> Upstream channel conditions
<input type="checkbox"/> Channelization	<input type="checkbox"/> Road encroachment	<input type="checkbox"/> Oil field water discharge
<input type="checkbox"/> Augmented flows	<input type="checkbox"/> Other (specify) <u>need to improve golf course management</u>
