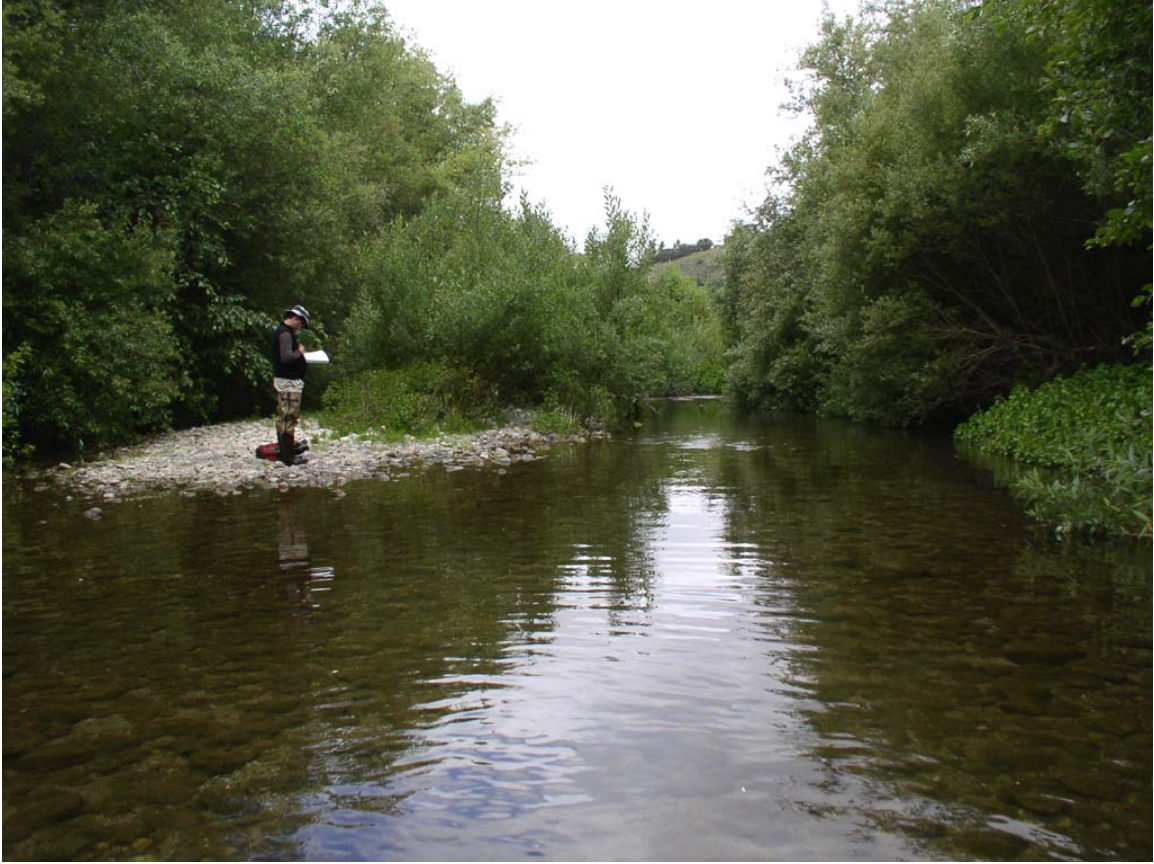
Primary riparian vegetation includes: black cottonwood, red and arroyo willow, white alder, and western sycamore. Many bullfrogs were observed in this reach. This reach also has a trapezoidal channel shape that is reinforced by concrete rubble. This reach could be considered function at risk because the Carmel Valley Golf Course is encroaching on the river on the south bank and the north bank is full of concrete rubble preventing natural sinuosity. In addition, Cal-Am's Scarlett well may dewater this area in a dry year.

Proper Functioning Condition	_____
Functional – At Risk	<u> X </u>
Nonfunctional	_____
Unknown	_____

<input type="checkbox"/> Flow regulations	<input type="checkbox"/> Mining activities	<input type="checkbox"/> Upstream channel conditions
<input type="checkbox"/> Channelization	<input type="checkbox"/> Road encroachment	<input type="checkbox"/> Oil field water discharge
<input type="checkbox"/> Augmented flows	<input checked="" type="checkbox"/> Other (specify) <u>golf course encroachment and concrete rubble</u>
