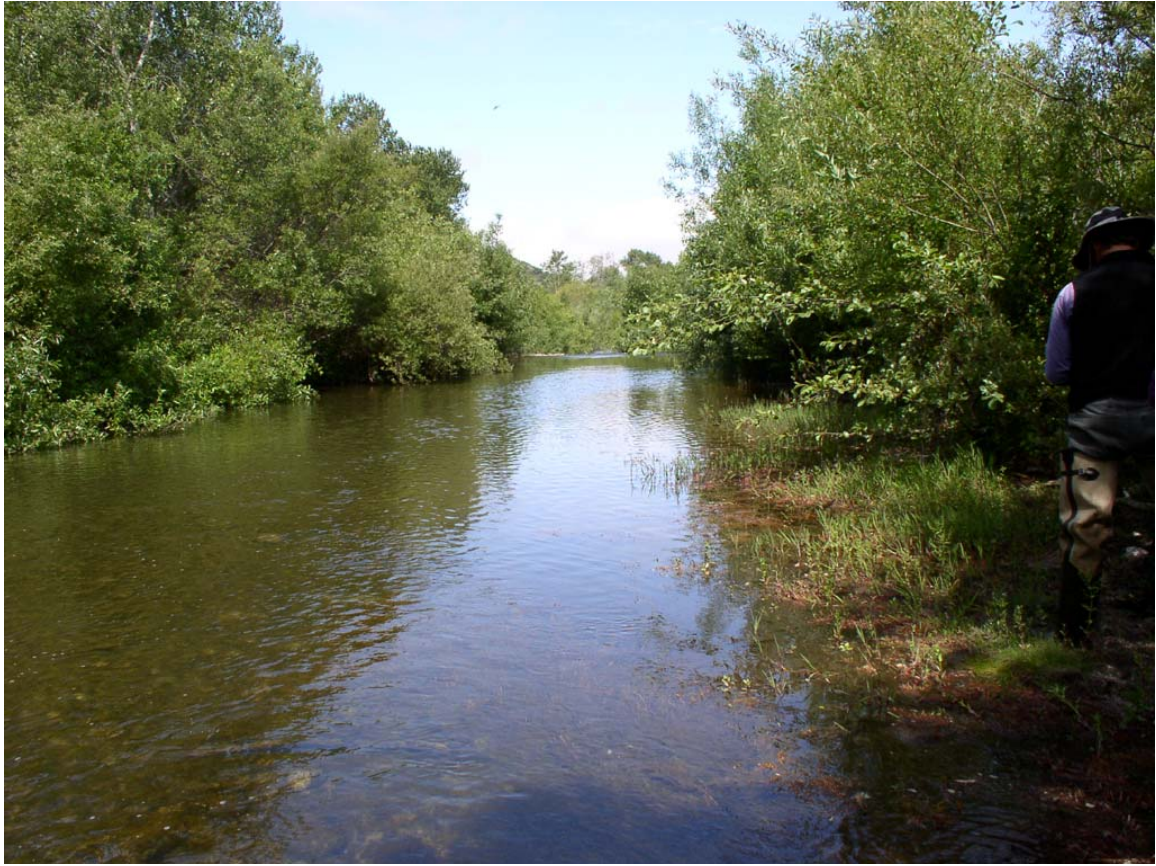
Primary riparian vegetation includes: black cottonwoods, red and arroyo willows, white alders, and western sycamore. This particular reach has rip-rap on the right bank that was installed to protect Carmel Valley road from erosion. An old historic meander was cut off when they rerouted Carmel Valley road in the early 1950's. Therefore, sinuosity and lateral stream movement are not considered in balance with the historic setting.
