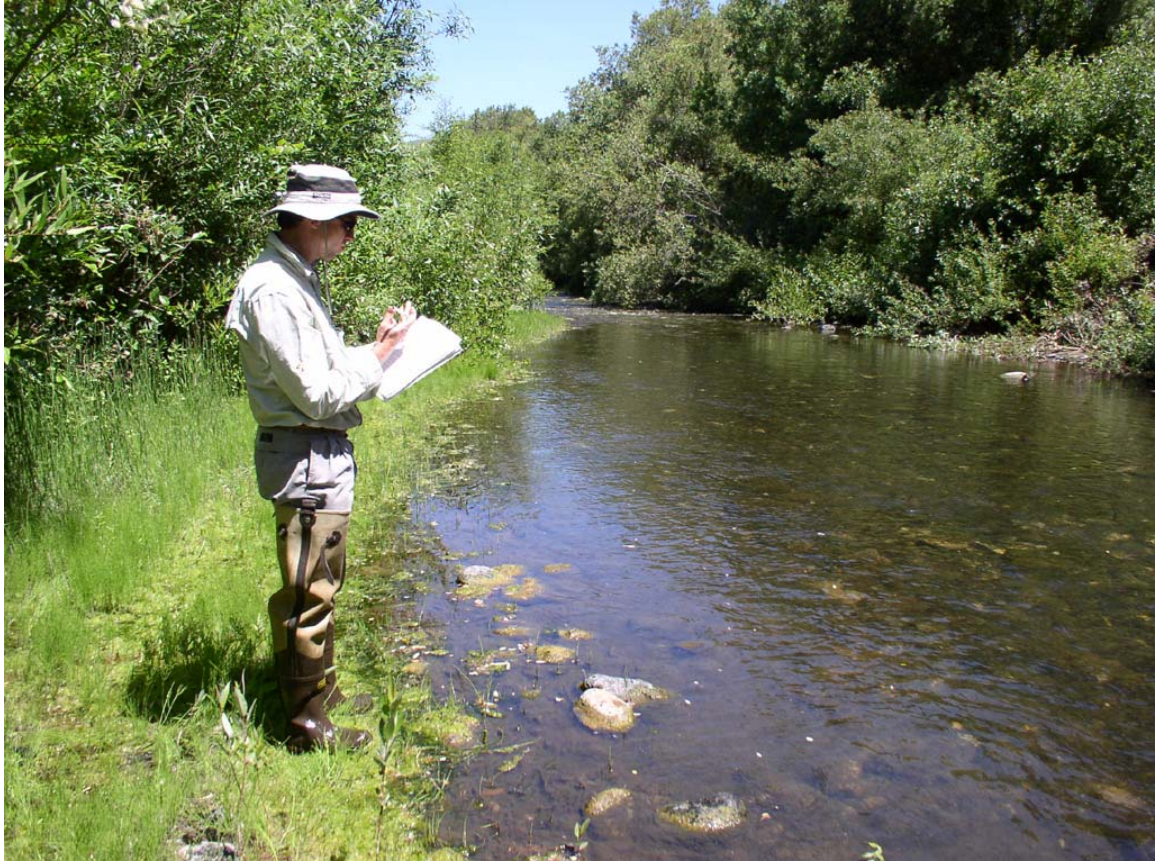
Primary riparian vegetation includes: black cottonwoods, red and arroyo willows, white alders, and western sycamore. This particular reach has rip-rap on the right bank. Willows are also topped at the Carmel River Ranch so guests have a view of the river.

Proper Functioning Condition	<u> X </u>
Functional – At Risk	<u> </u>
Nonfunctional	<u> </u>
Unknown	<u> </u>
