Standard Checklist

Name of Riparian – Wetland Area: Carmel River Watershed – Garland Park Area

Date: 6/2/04 Segment/Reach ID: 18-Carmel River at cliff area just upstream of

Garland Park

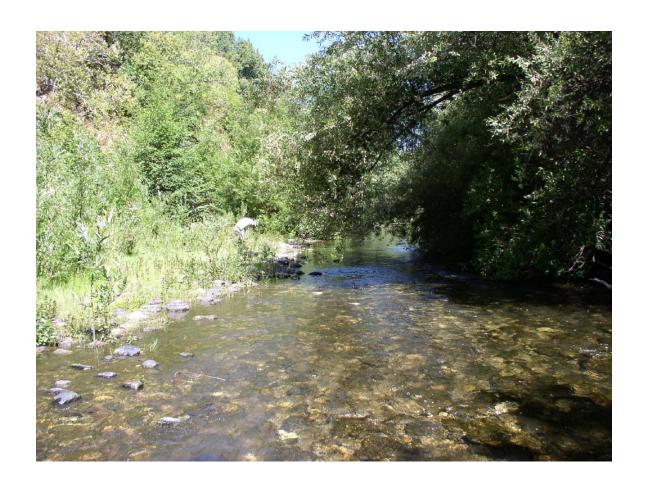
Primary riparian vegetation includes: black cottonwoods, red and arroyo willows, white alders, Santa Barbara sedge, and western sycamore. The canopy in this reach creates lots of shade for the open channel, which helps control water temperature.				
C	Determination			
Summary	Determination			
Functional Rating:				
Proper Functioning Condition	X			
Functional – At Risk				
Nonfunctional				
Unknown				
Trend for Functional – At Risk:				
Upward				
Downward				
Not Apparent				
Are factors contributing to unacceptable conditions outside the control of the manager?				
Yes
