## **Standard Checklist**

Name of Riparian - Wetland Area: Carmel River Watershed - Garzas Creek Area

Date: 6/2/04 Segment/Reach ID: 19-Carmel River at West Garzas Well

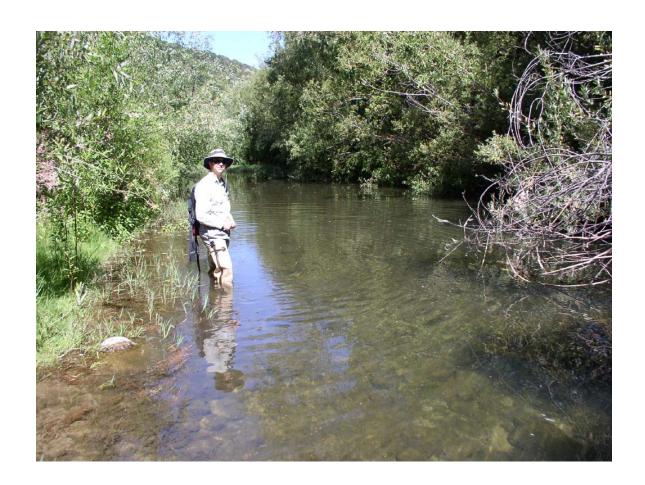
Primary riparian vegetation includes: black cottonwoods, red and arroyo willows, white alders, Santa Barbara sedge, and western sycamore.						
Summary Determination						
Functional Rating:						
Proper Functioning ConditionX						
Functional – At Risk Nonfunctional						
Unknown						
Trend for Functional – At Risk:						
Upward						
Downward Not Apparent						
Are factors contributing to unacceptable conditions outside the control of the manager?						
Yes No _ <u>X</u>						
If yes, what are those factors?						
Flow regulations Mining activities Upstream channel conditions Channelization Road encroachment Oil field water discharge Augmented flows Other (specify)
