## **Standard Checklist**

Name of Riparian - Wetland Area: Carmel River Watershed - Esquiline Bridge Area

Date: 6/28/04 Segment/Reach ID: 21-Carmel River at Esquiline Road Bridge or

ID Team Observers: Paul Watters

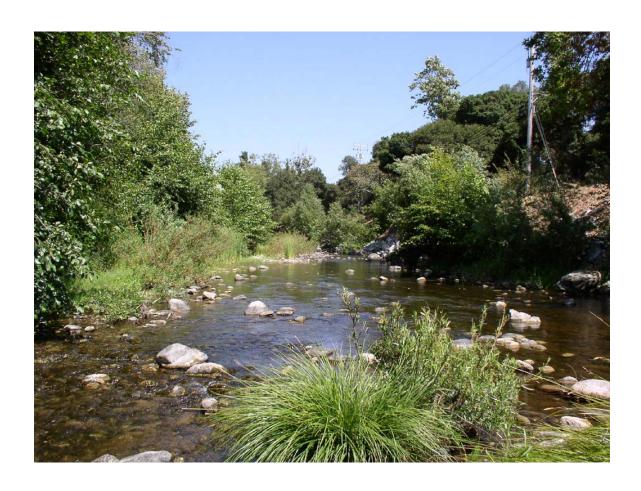
Riparian species include white alder, Santa Barbara sedge, red and arroyo willows, black cottonwoods, and western sycamore. This reach was rated functional at risk because some levees had sparse riparian vegetation and the reach is bank hardened.
