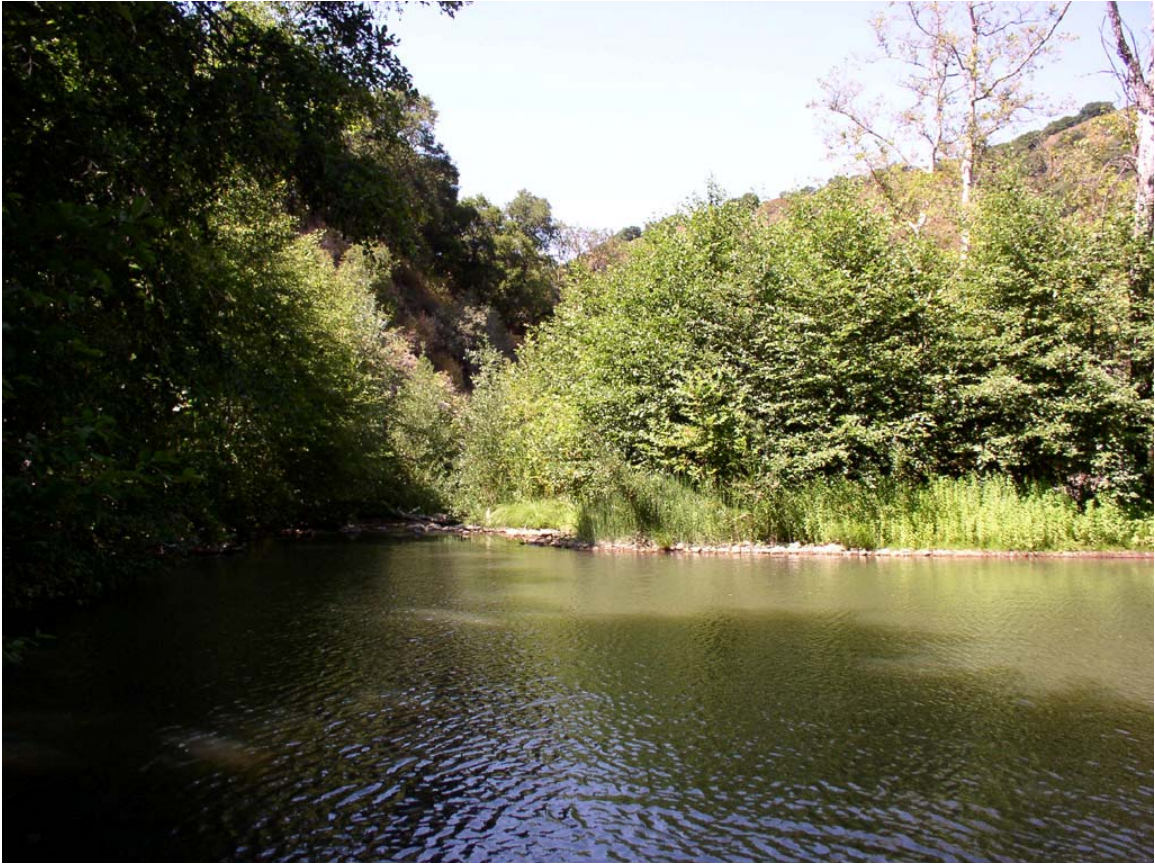
San Clemente Dam is almost completely filled in with sediment. Reservoir drawdown in the spring required by the Department of Safety of Dams has caused an increase in turbidity downstream of the dam in the Carmel River. Riparian plants in this reach consist of white alders, black cottonwoods, sycamores, red, and arroyo willows.
