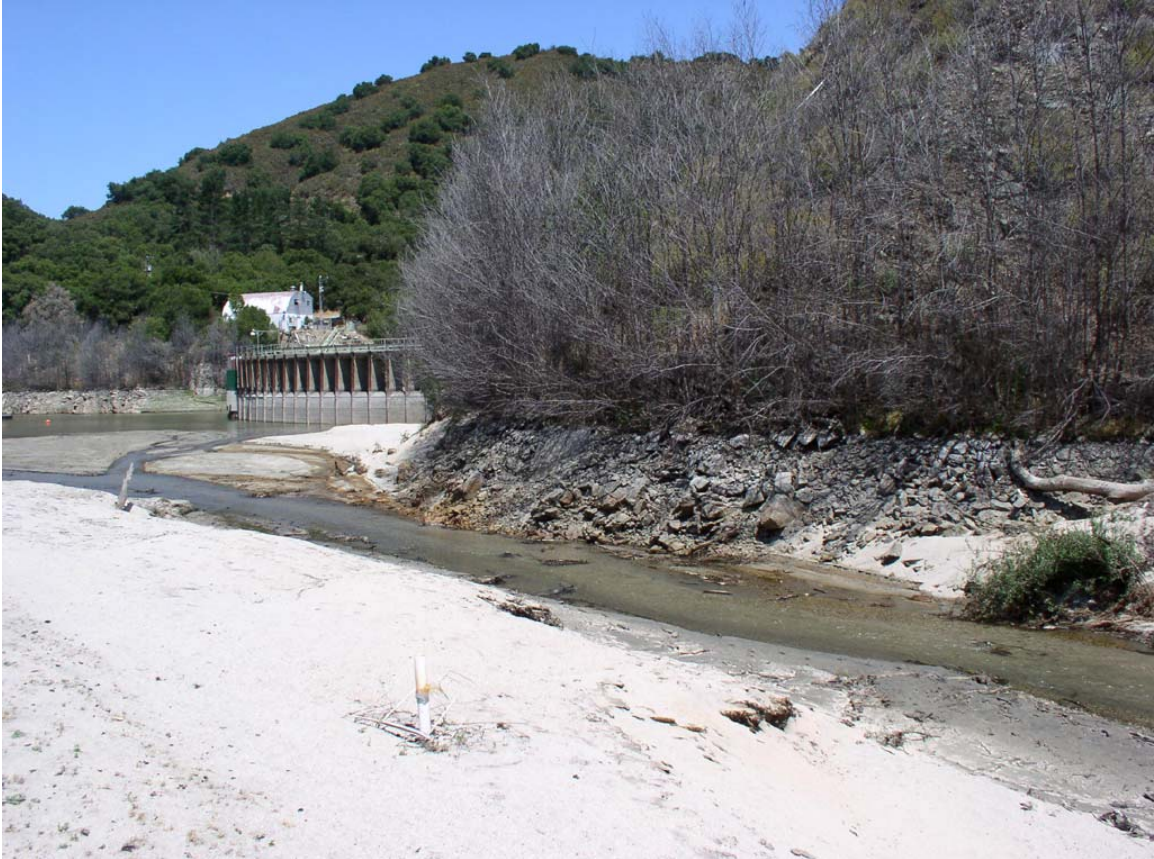
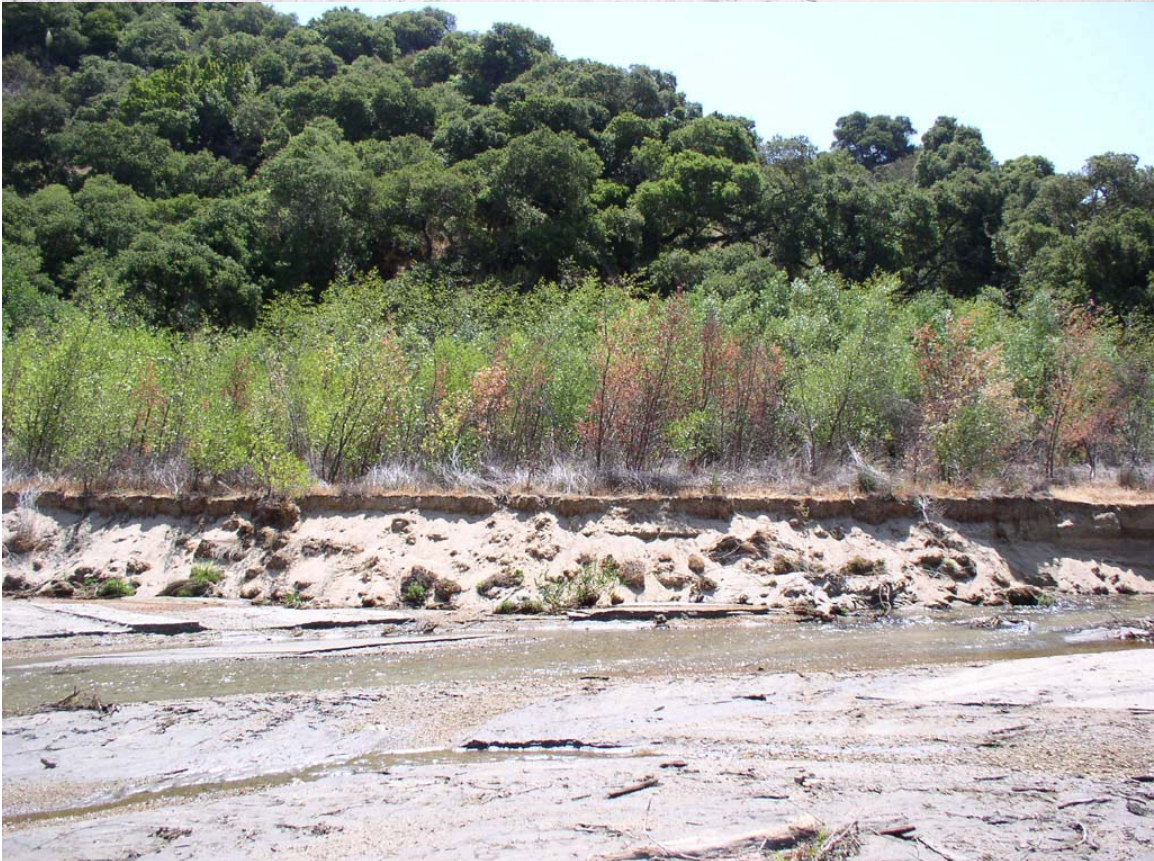
San Clemente Dam is almost completely filled in with sediment. Reservoir drawdown in the spring required by the Department of Safety of Dams has caused the Carmel River to down cut through the sediment plain behind the dam. This has led to loss of riparian vegetation and the destabilization of banks for approximately a half mile upstream of San Clemente Dam.
