## Standard Checklist

Name of Riparian – Wetland Area: Carmel River Watershed – Pine Creek Area

Date: 10/24/03 Segment/Reach ID: 28-Carmel River 1/2 way to Pine Creek from Syndicate Camp

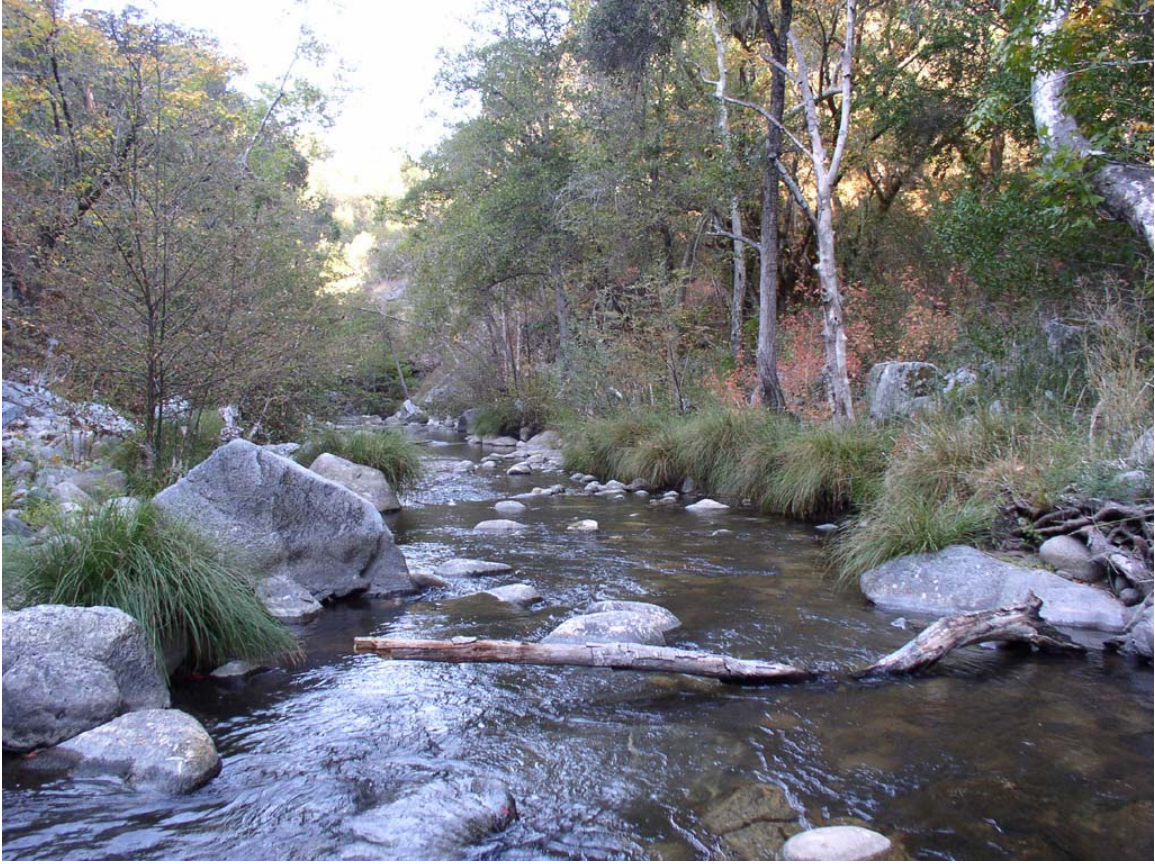
Canyon controlled channel with large class boulders and angular rock. Primary riparian vegetation includes: willows, white alders, Santa Barbara sedge, and western sycamore.
