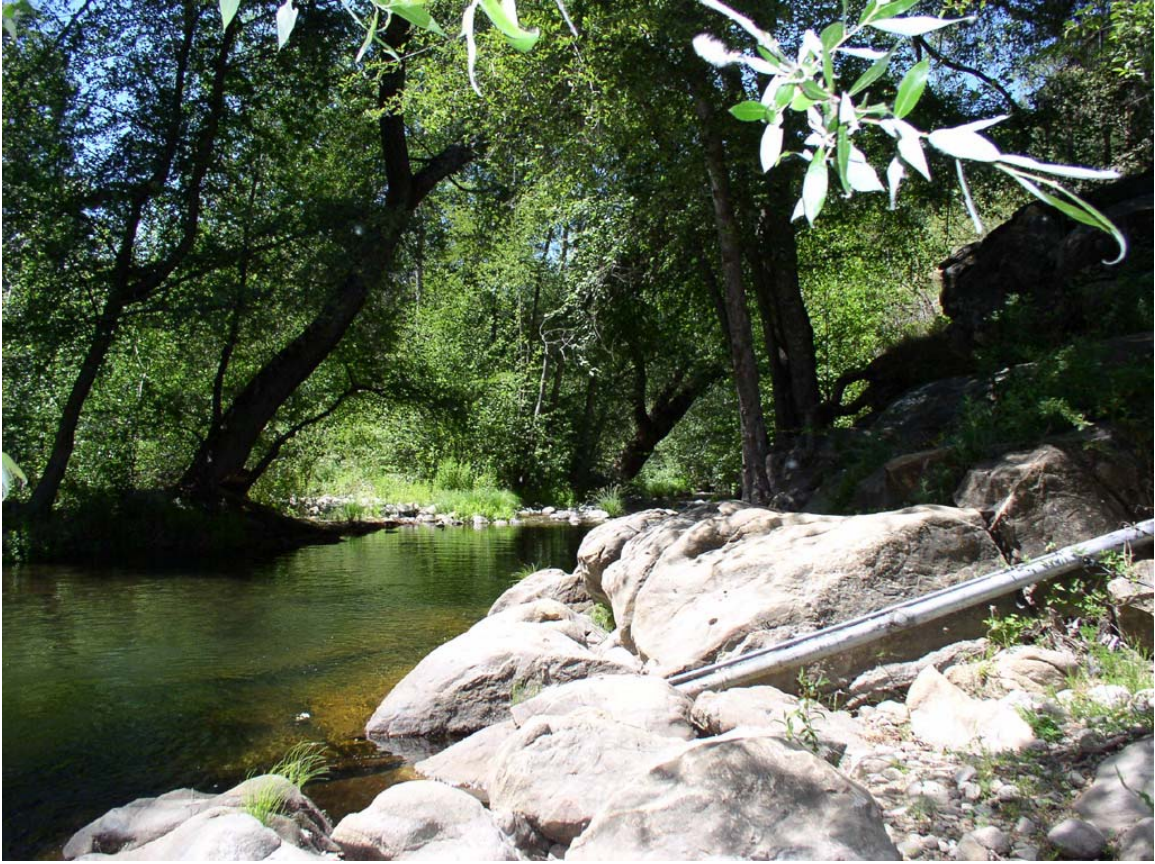
This reach receives fine to medium grade sediment (i.e. sand and gravel) input from the Cachagua drainage. Sediment input can be significant during wet years. Primary riparian vegetation includes: willows, white alders, Santa Barbara sedge, and western sycamore.

Proper Functioning Condition	<u> X </u>
Functional – At Risk	<u> </u>
Nonfunctional	<u> </u>
Unknown	<u> </u>
