Standard Checklist

Name of Riparian - Wetland Area: Carmel River Watershed - Cachagua Area

Date: 5/12/04 Segment/Reach ID: 31-Carmel River just downstream of Cachagua

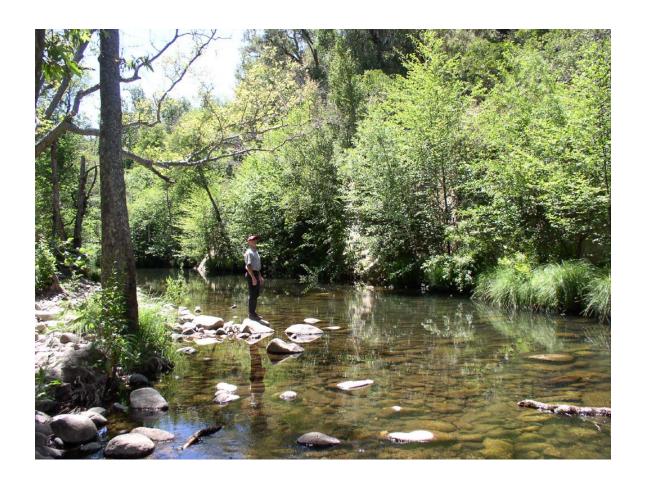
Reach has a lack of fine to medium grade material (i.e. sand and gravel) and has undergone some incision. The root cause of this problem is caused by Los Padres Dam constructed in 1948, which traps the majority silt and sand. Primary riparian vegetation includes: willows, white alders, Santa Barbara sedge, and western sycamore.
