Standard Checklist

Name of Riparian – Wetland Area: Carmel River Watershed – Los Padres Reservoir

Date: 6/30/04 Segment/Reach ID: 32-Carmel River just above Los Padres Dam

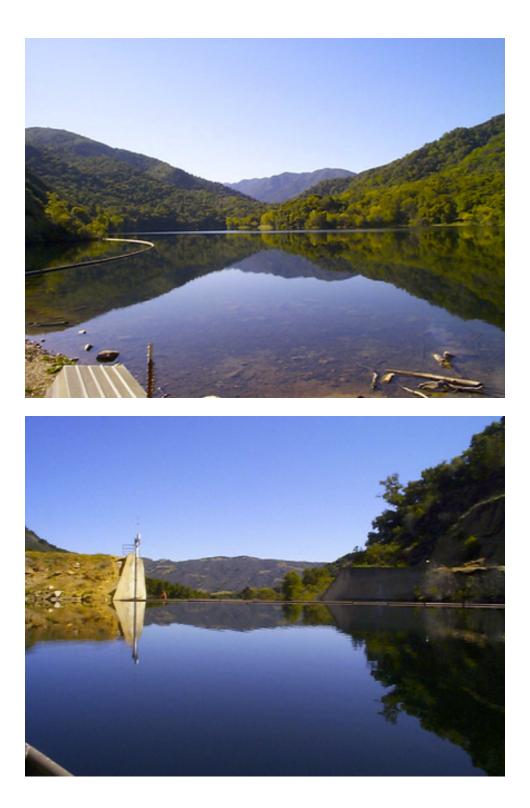
Los Padres Dam is almost half-filled in with sediment.
