Standard Checklist

Name of Riparian - Wetland Area: Carmel River Watershed - Miller Fork Area

Date: 1/28/04	Seg	gment/Reach ID: 3	3-Carm	el River at Bl	uff Camp below Miller
	For	:k			
Miles:	Acres:	Coordinates:	Begin	5778052 E	2028706 N
			End	5780241 E	2023388 N
ID Team Observers: Thomas Christensen and Larry Hampson

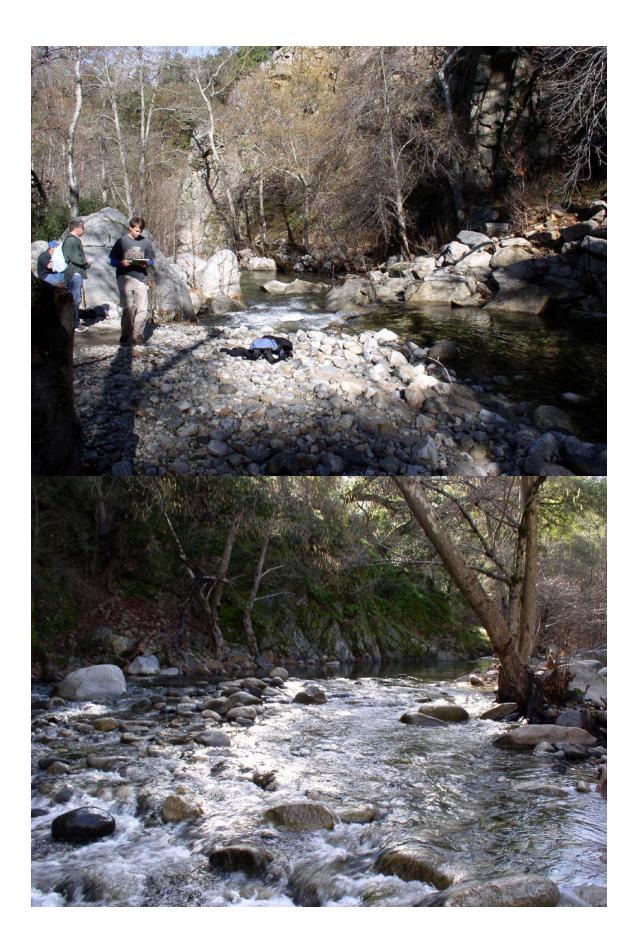
Lots of large size class boulders and cobble to dissipate energy. Riparian species include white alder, and western sycamore.
