Standard Checklist

Name of Riparian – Wetland Area: Carmel River Watershed – Miller Fork Area

Date: 1/28/04 Segment/Reach ID: 34-Carmel River at Miller Fork Confluence

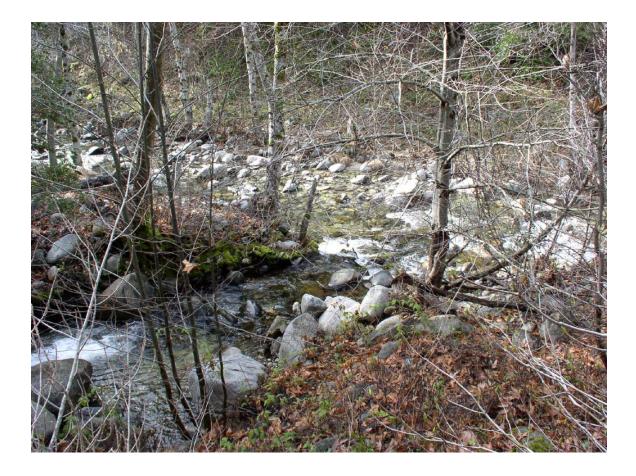
Large boulders and cobble exist to dissipate energy. Riparian species include white alder, Santa Barbara sedge, and western sycamore.

Proper Functioning Condition	<u>X</u>
Functional – At Risk	
Nonfunctional	
Unknown
