Standard Checklist

Name of Riparian – Wetland Area: Carmel River Watershed – Pine Valley Area

Date: 4/8/04 Segment/Reach ID: 37-Carmel River just below cabin in Pine Valley

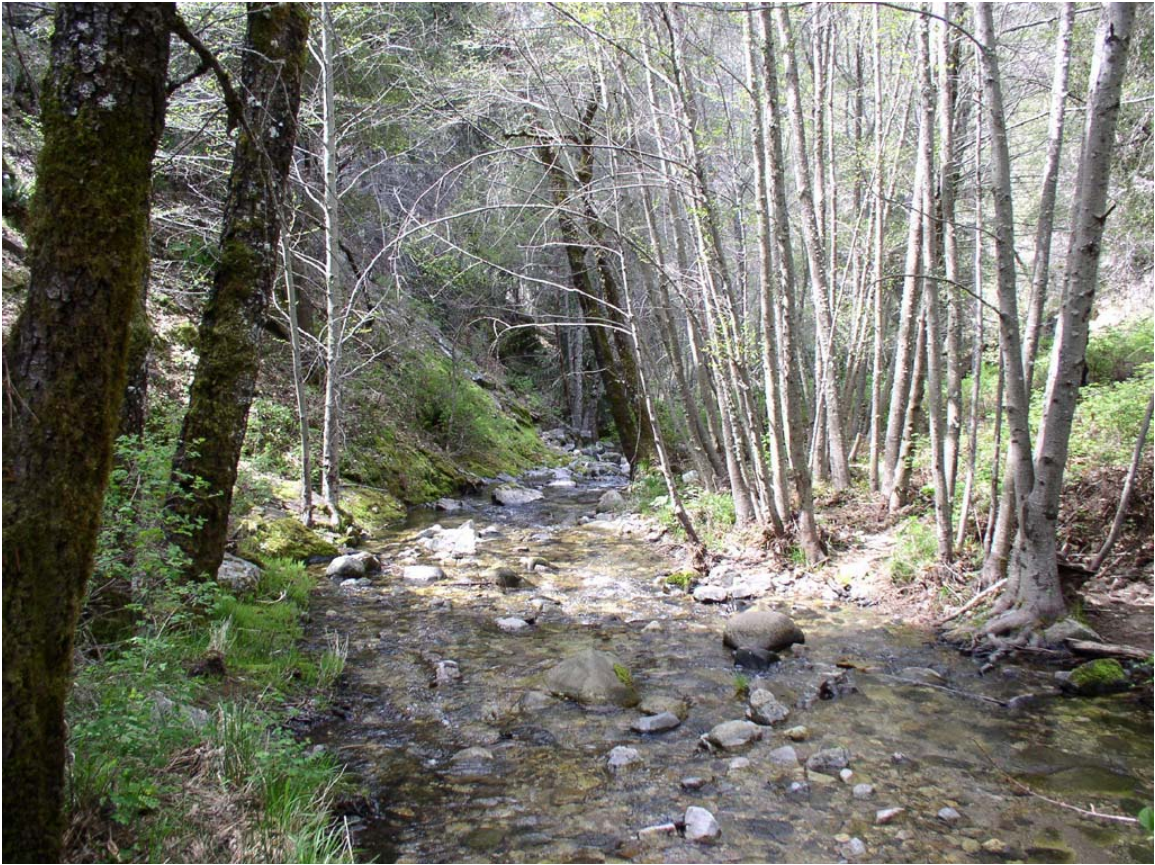
Most of the riparian cover along the stream consists of white alders and Santa Barbara sedges. Black cottonwoods were observed on the alluvial floor of Pine Valley in open sun areas.
