## Standard Checklist

Name of Riparian-Wetland Area: Conejo Creek - Intermittent cattle creek

Date: July 21, 2004 Segment/Reach ID: Reach 2 PFC 152

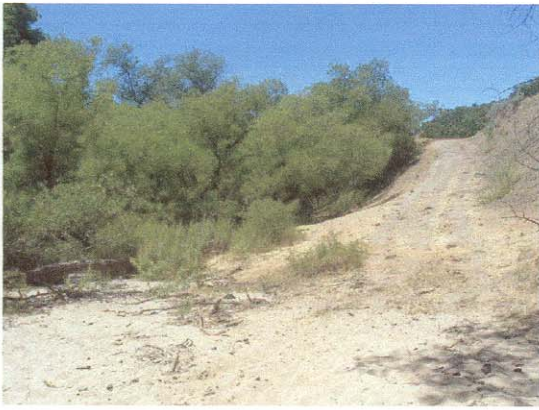
Picture 1

This area has been extremely degraded by cattle, unstable dirt roads and trails, and a summer dam used for cattle watering (Picture 1). There is cattle dung in the creek bed throughout this reach.

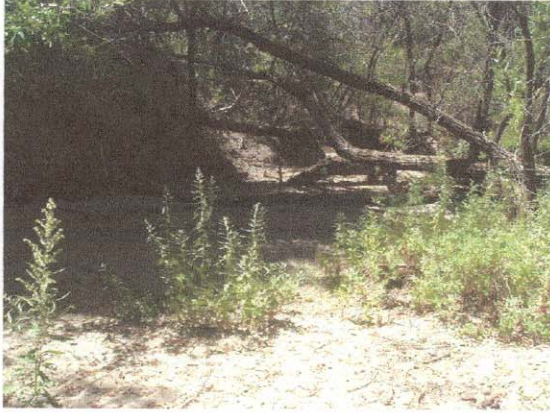
Picture 2

There is extreme sediment deposition, never more shallow than 8 inches deep. No cobbles or boulders are visible in the creek bed (Picture 2).

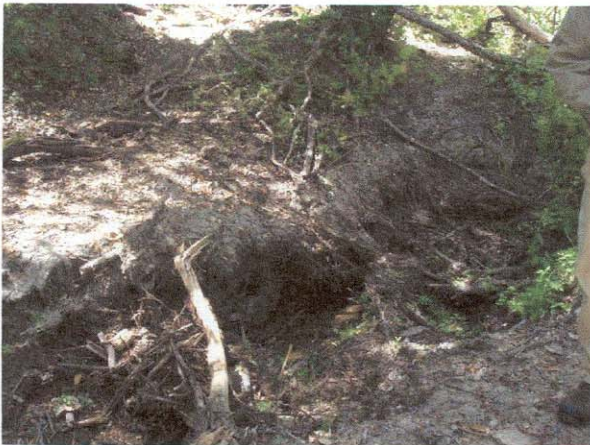
Picture 3

There are multiple instances of undercutting in the reach (Picture 3).

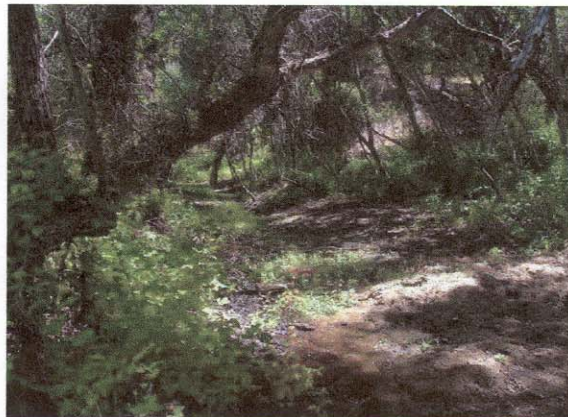
Picture 4

There is no understory in many areas, and where there is vegetation it is predominated by upland species. Vegetation becomes more dense toward the end of the reach where there is less cattle impact (Picture 4).
