Standard Checklist

Name of Riparian-Wetland Area: Robinson Canyon Creek

Date: June 25, 2004 Segment/Reach ID: Reach 9 PFC 202

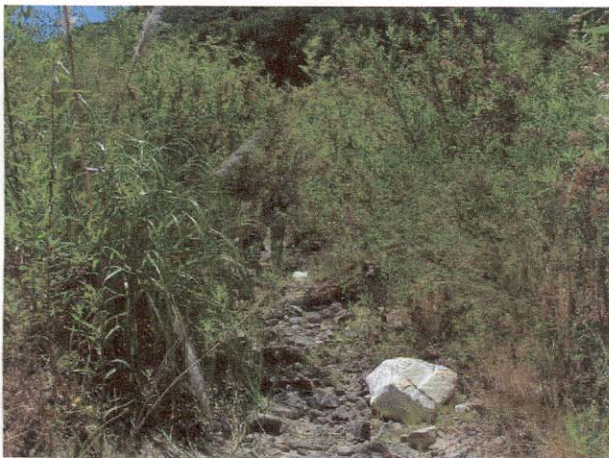
Picture 1

This area has been armored since the 1998 flood. There is a large area that is void of vegetation, one bank has been cleared below a house and the other is eroding. There is armoring throughout the reach some of which is concrete rubble (See Picture 2). There is a bare cut road on the east bank that has been armored with quartz boulders since 1998, however large chunks of these boulders were found down stream from here (See Picture 1).

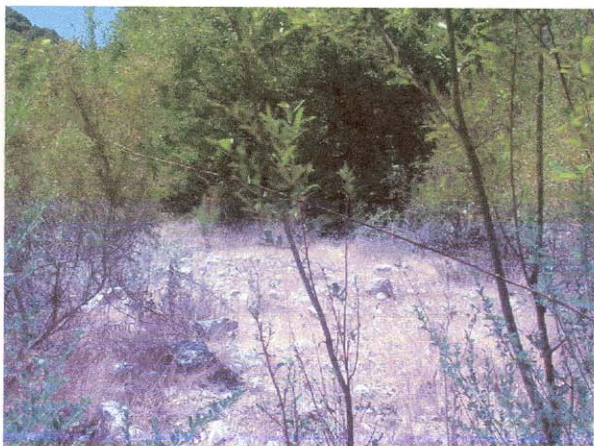
Near bridge 508 there is a floodplain void of vegetation with a bare bank leading to a wooden fence directly upland from it (See Picture 3).
