## Standard Checklist

Name of Riparian-Wetland Area: Robinson Canyon Creek

Date: June 25, 2004 Segment/Reach ID: Reach 8 PFC 203

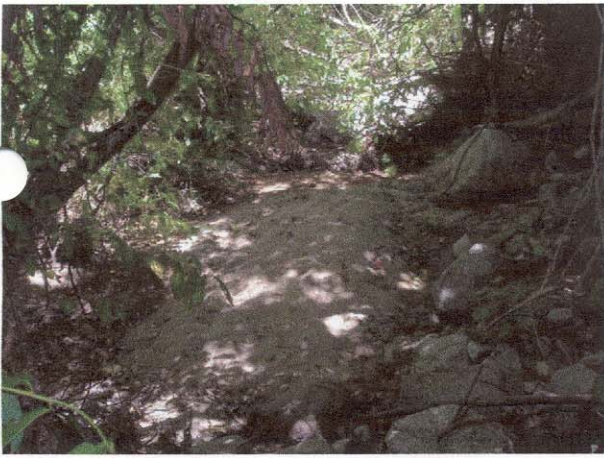
Picture 1

There is still excess sediment in the reach, however some cobbles were also observed in the stream bed (See Picture 1).

#5, 17 There is excess fine sediment found throughout the reach.

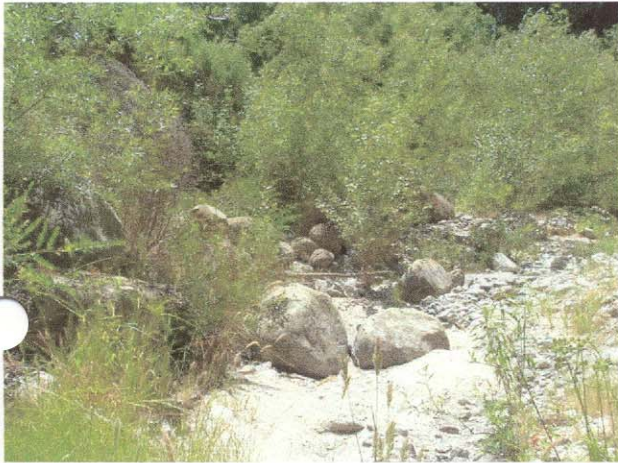
Picture 2

This reach is in an urban area and seems to be suffering from a low water table as the floodplain above bankfull is not inundated relatively frequently and the vegetation is suffering. There are no grasses in this area and the younger willows and buckeyes are brittle with yellowing leaves (See Picture 2). There are upland species present and point bars are not revegetating.

#1, 8, 10 The floodplain above bankfull is dry and has upland plants inhabiting it along with stressed willows and buckeyes.
