Standard Checklist

Name of Riparian-Wetland Area: Robinson Canyon Creek

Date: June 29, 2004 Segment/Reach ID: Reach 3 PFC 208

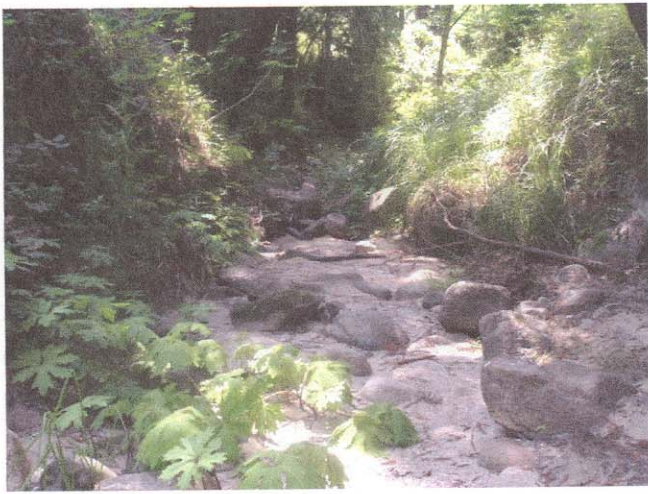
There is a large log jam at the end of the reach that could be a fish impairment (See Picture 4). Vegetation became more abundant as the proximity of the roads and driveways lengthened.

Picture 4 Logjam at end of reach

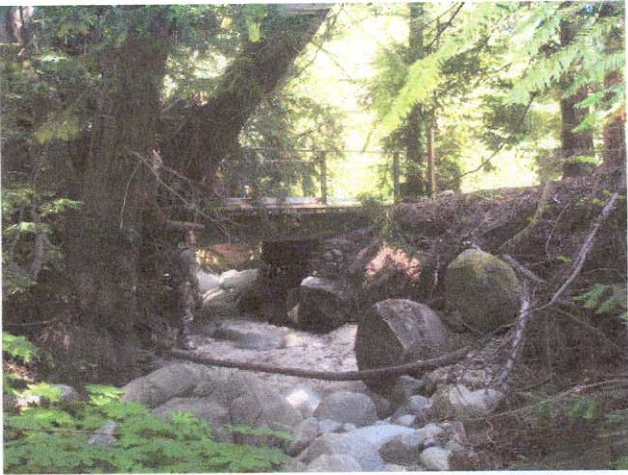
Picture 1

There are large sediment deposits, likely contributed to by recent construction (See Pictures 1, 2 and 3).

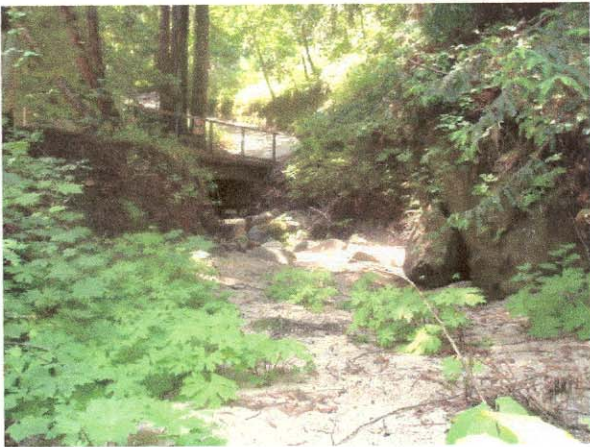
There are two relatively new private bridges that seem unaffected by high flows. They were likely built after 1998 and their ability to withstand flood conditions is unknown (See Pictures 2 and 3).

Picture 2 Upstream side of first new bridge
