Standard Checklist

Name of Riparian-Wetland Area: Robinson Canyon Creek

Date: June 29, 2004 Segment/Reach ID: Reach 1 PFC 210

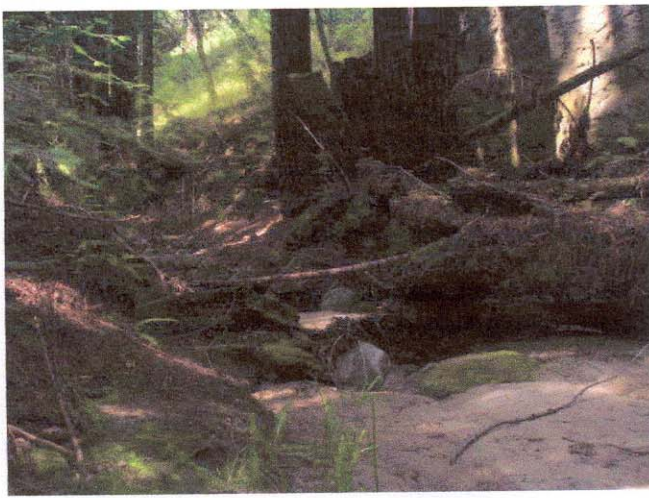
Picture 1 Logjam on the west bank, looking downstream, with a large sediment pile in front of it.

This reach began near the property line of the Santa Lucia Preserve at mile marker 6.75 on Robinson Canyon Rd.. There is an eroding bank upland from the logjam where these redwoods apparently fell from. This eroding upland is contributing sediment and continues to be unstable (See Pictures 1, 2, 3 and 4).

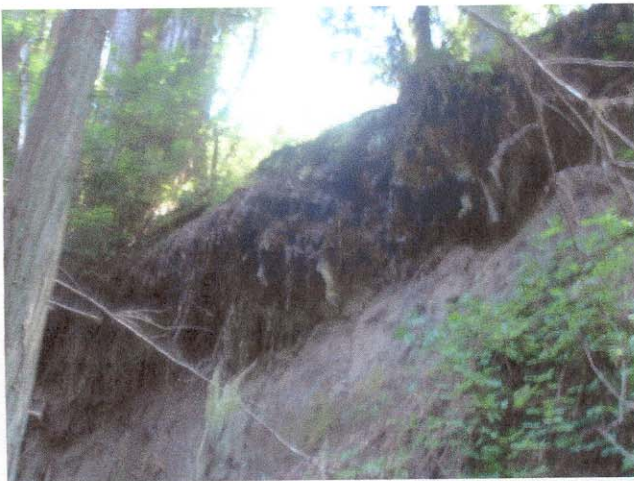
Picture 2 Eroding and unstable overhang wall directly above logjam.

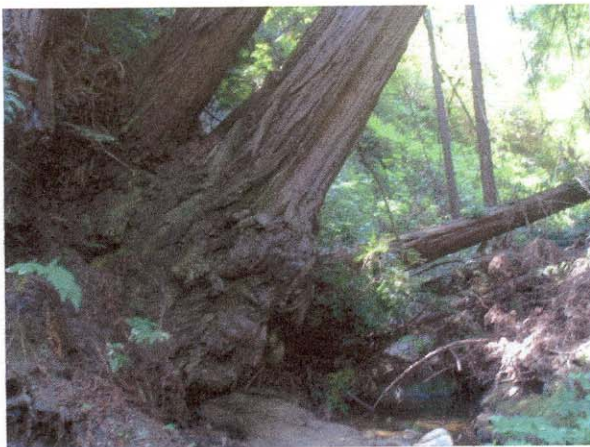
Picture 3 View of logjam from downstream

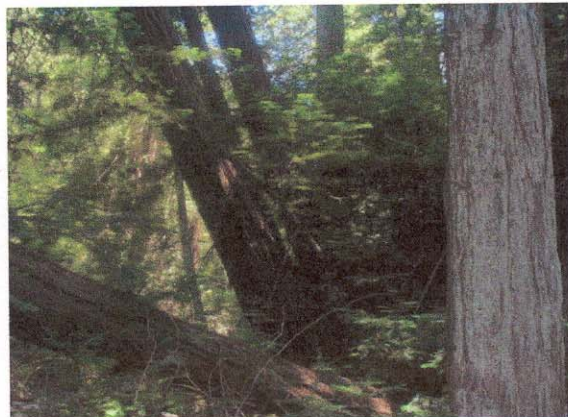
Picture 4 Upstream view of logjam (opp. of Picture 3)
