Standard Checklist

PFC 301

Name of Riparian-Wetland Area: Hitchcock Creek

Date: May 24, 2004 Segment/Reach ID: Reach 1, Mainstem at Rosie's Bridge

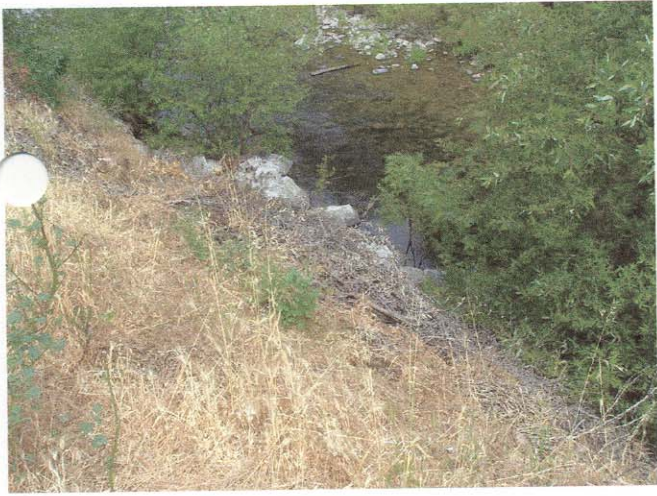
There is a large pile of loose brush/ yard waste that was dumped on a 100ft wide area of the downstream, road side bank (See Picture 1).
