## Standard Checklist

Name of Riparian-Wetland Area: Hitchcock Creek

Date: May24, 2004 Segment/Reach ID: Reach 2, Rosie's Bridge PFC 302

ID Team Observers: Clive Sanders, Danica Zupic Time: 11:00 am

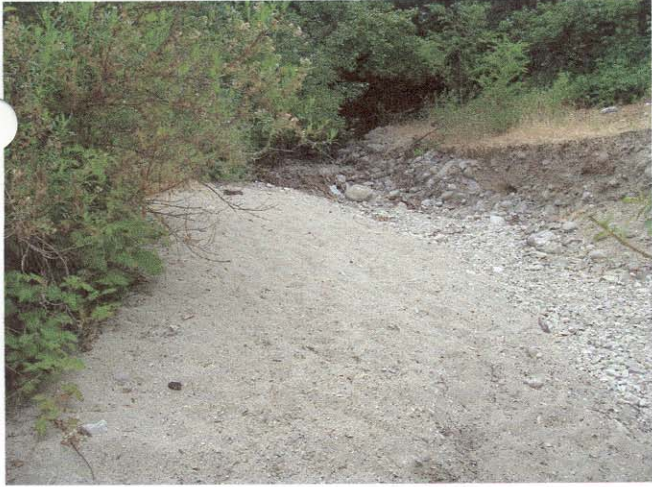
Picture 1

There is a sediment deposit over 10 ft. long ( See Picture 1).

Both banks are severely eroding and exposing tree roots. The sandbags, tires and concrete used to stabilize the banks are deteriorating and being strewn downstream (See Pictures 1, 2 and 3). There was a washed out fence along with a lot of sediment sliding into the creek on the downstream left side.

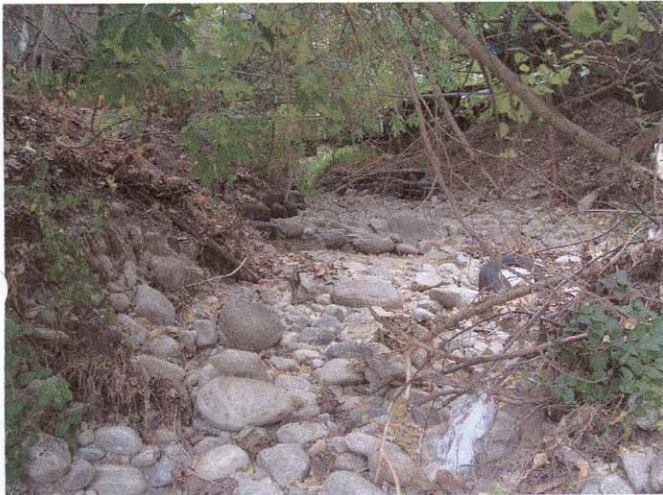
Picture 2

The vegetation is sparse. There are a few mature trees, there are no recruits, grasses, or bushes (See Pictures 2 and 3). The only vegetative cover seen helping to stabilize the banks is *Vinca major*.
