## Standard Checklist

Name of Riparian-Wetland Area: Hitchcock Creek

Date: June 7, 2004 Segment/Reach ID: Reach 9 house 26- bridge 516 PFC 309

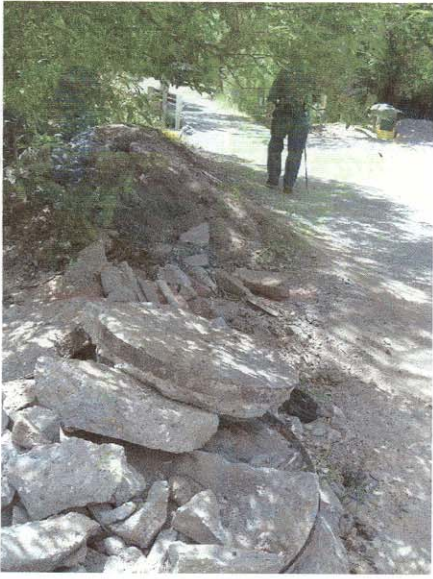
Picture 1

There are piles of concrete rubble, and dirt next to the street and sliding down the bank into the creek (See Pictures 1, 2, 3, and 4).

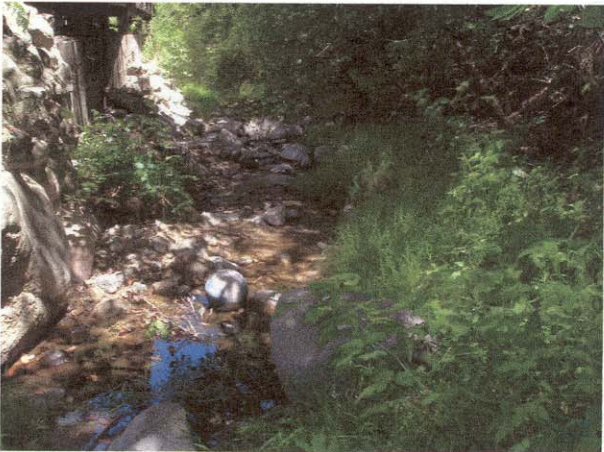
Picture 4

The next house also has a buttressed bank walls that are stable downstream but are eroding upstream. The owner has tried to further stabilize the bank with concrete rubble (See Picture 4).
