# Standard Checklist

Name of Riparian-Wetland Area: Hitchcock Creek PFC 311

Date: May 27, 2004 Segment/Reach ID: Reach 11, Piered house on 49 Southbank

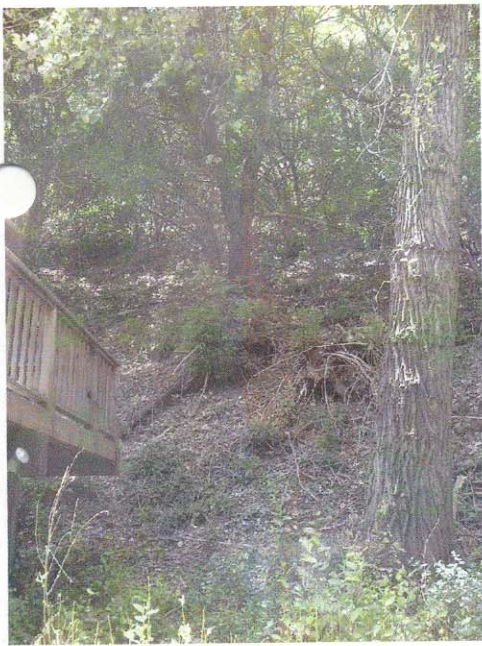
Picture 1

Severe erosion is occurring on the hillside behind the house and under the house (See Pictures 1, 2, 3, 4). The hill behind the house is undercut and there are tree roots exposed (See Picture 2).

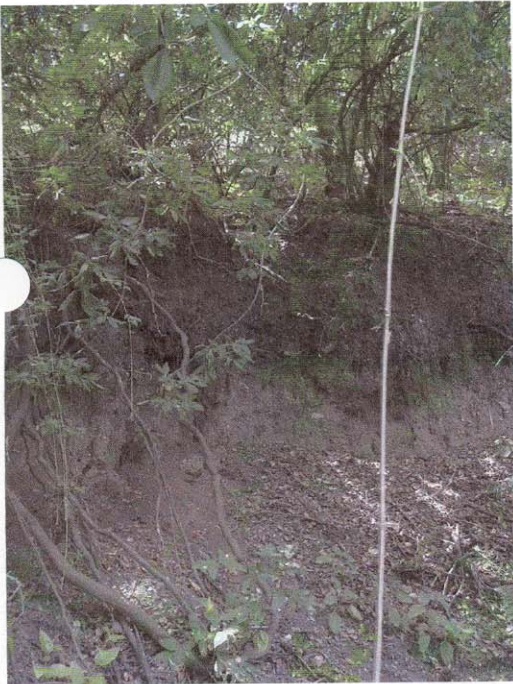
Picture 2

There is a lack of vegetation behind and beside the house. Next to the house is a lawn where two trees were recently cut down (See Pictures 2 and 3). There are few new recruits, grasses or bushes and the only ground cover found was *Vinca major*.

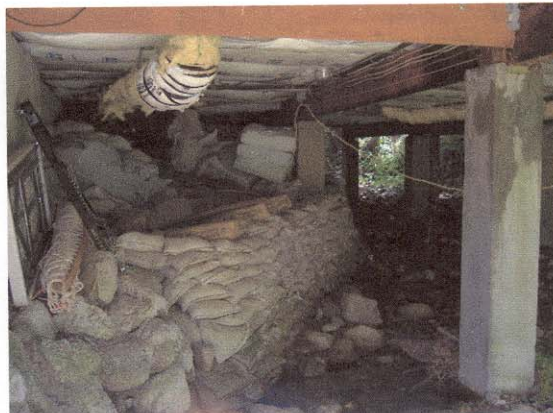
Under the house are 4-6 concrete piers, which seem to be directing the creek further under the house (See picture 4). There are three rows of sandbags 3 ft. high to protect the foundation of the house.
