# Standard Checklist

Name of Riparian-Wetland Area: Hitchcock Creek

Date: June 15, 2004 Segment/Reach ID: Reach 21 - Kahn Ranch PFC 321

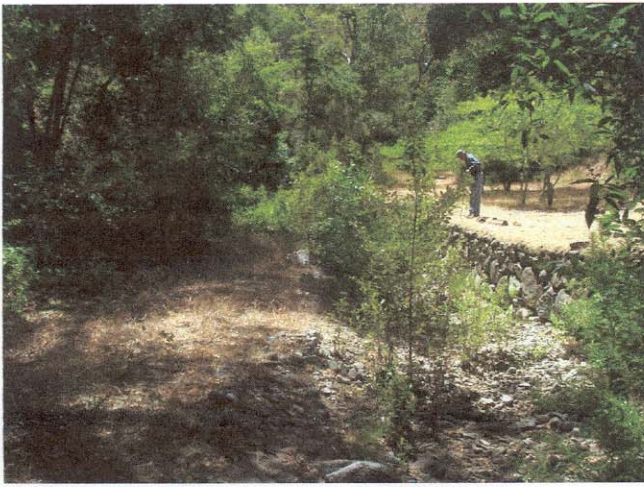
Picture 1

The beginning of the reach used to be grazing land and since has been cut back for fire hazards. The first 200 yards is very bare without many recruits, or large trees. Much of the creek here was buttressed with large concreted rocks many years ago and is still stable and functioning properly (See Picture 1). There are the remnants of old summer dams. One of the walls is starting to become undercut (See Picture 2).

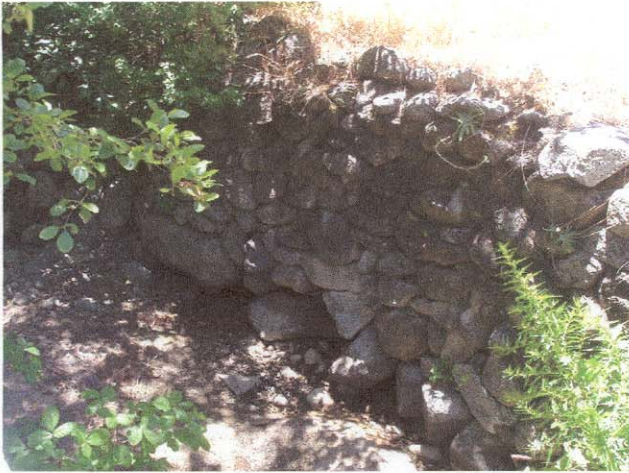
Picture 2

#16 The system is not vertically stable where the wall is becoming undercut.

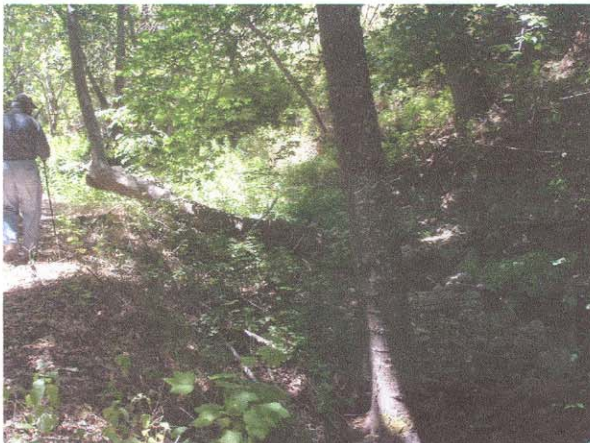
Picture 3

There was plenty of LWD throughout the reach (See Picture 3). There a couple places where some hillsides were eroding and contributing some sediment to the creek, however, it was at a normal rate.
