Standard Checklist

Name of Riparian-Wetland Area: Hitchcock Creek

Date: June 23, 2004 Segment/Reach ID: Reach 22 -(escarpment) PFC 322

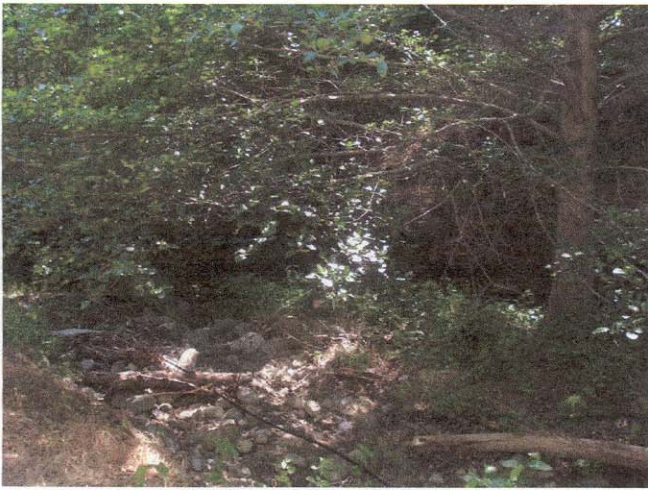
Picture 1

The reach started at the fork of the Fern Falls and the Hitchcock Loop trails. There is a rudimentary road/ foot and horse trail along the north bank of the creek. There upland area on the side of the road is eroding (See Pictures 2 and 3). The stream bank is incised. These ground observations support aerial observations noted by Doug Smith of CCoWS. The vegetation in the creek bed and banks is diverse in both age class and composition (See Picture 1). The upland species are predominantly oak, buckeye, other chaparral and monkey flower.

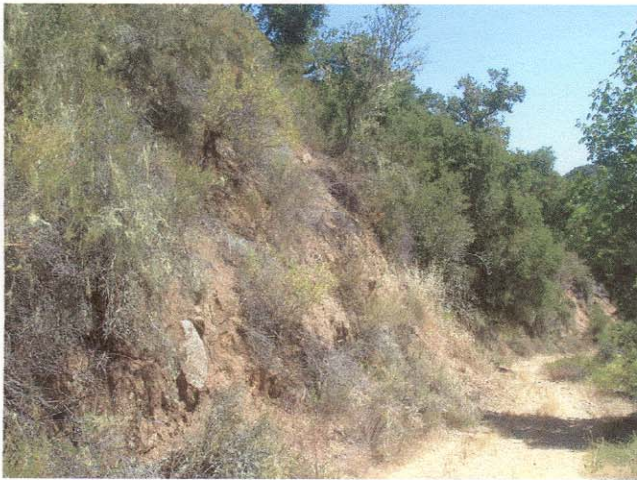
Picture 2

Despite the eroding hills and the land slides the reach is considered to be in PFC because this reach seems capable of handling the excess sediment as there is no excessive deposition. It should be noted that these two items may be contributors to the excessive deposition further downstream.

#5, 16 There is natural erosion occurring by the road/trail, however, there is no excessive deposition in this reach.

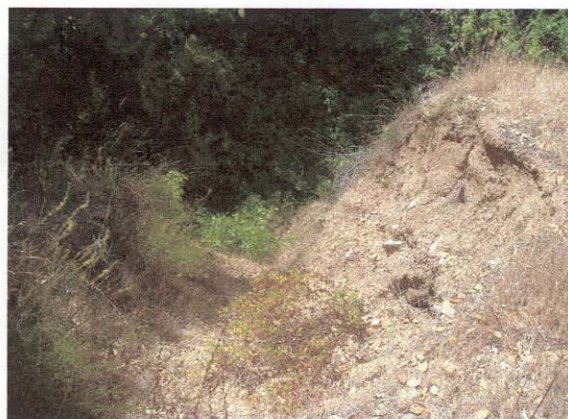
Picture 4

There was one spot where there was a large land slide or pit on the creek bank near the end of the reach (See Picture 4).
