# Standard Checklist

Name of Riparian-Wetland Area: Cachagua Creek

Date: July 23, 2004 Segment/Reach ID: Reach 15 PFC 401

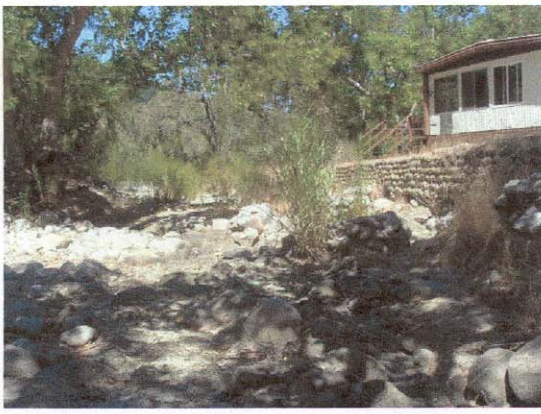
Picture 1

The area is predominantly residential, there is minimal riparian wetland vegetative understory, abundant dried algae, several buttressed banks and lots of household garbage to be found (See Picture 1).

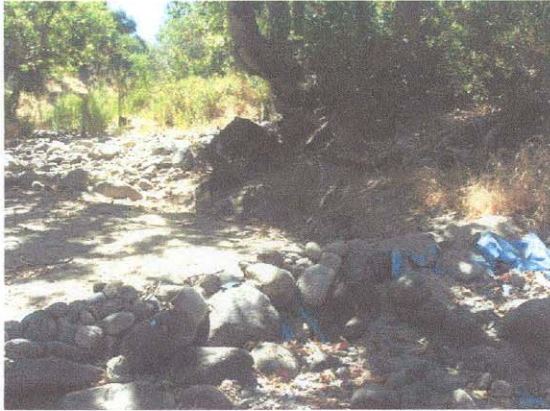
Picture 2

There is a summer dam filled in with sediment, with lots of bank erosion nearby (See Picture 2).

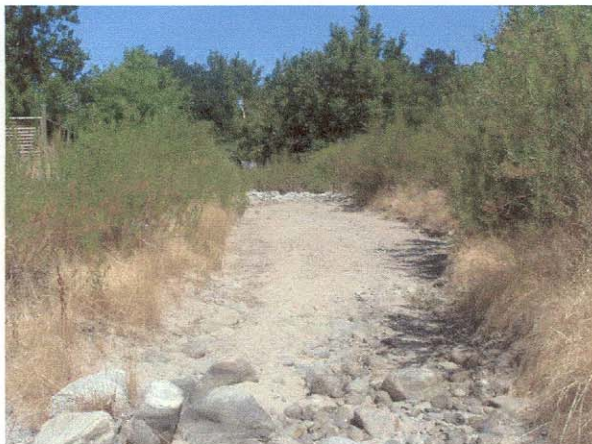
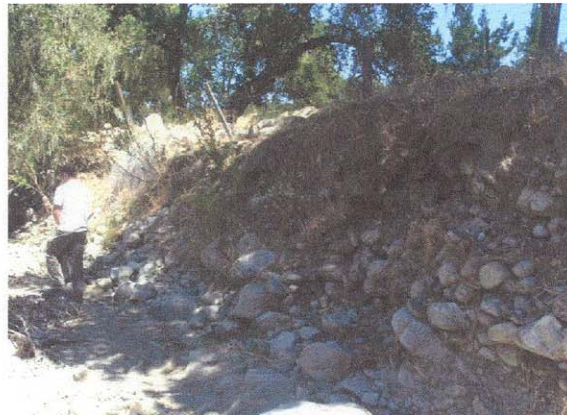
Along the roadside several banks are buttressed with boulders and lack vegetative cover, and there are several dirt pushes. There are several eroding banks and an excess of sediment in the creek bed (See Pictures 3 and 4).

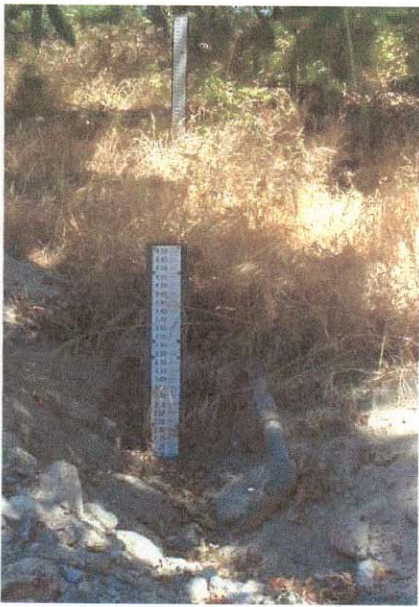
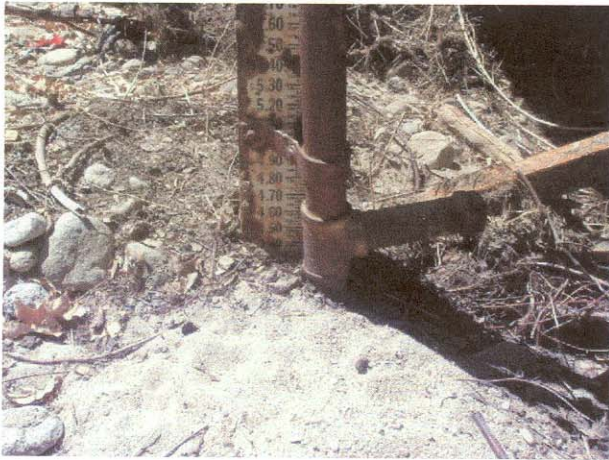
At the county bridge at Nason Road, two flow gauges were observed. Both gauges are buried in sediment, one up to the two foot marker, the other up to the four foot mark (See Pictures 5 and 6).

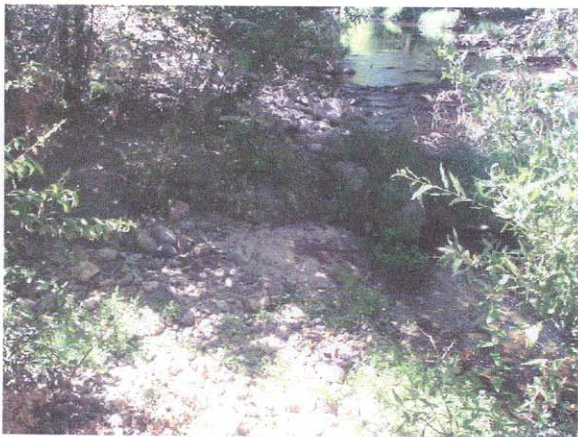
Picture 7

Vegetation thickens toward the confluence with the Carmel River (See Picture 7).
