Standard Checklist

Name of Riparian-Wetland Area: Cachagua Creek

Date: July 23, 2004 Segment/Reach ID: Reach 14 PFC 402

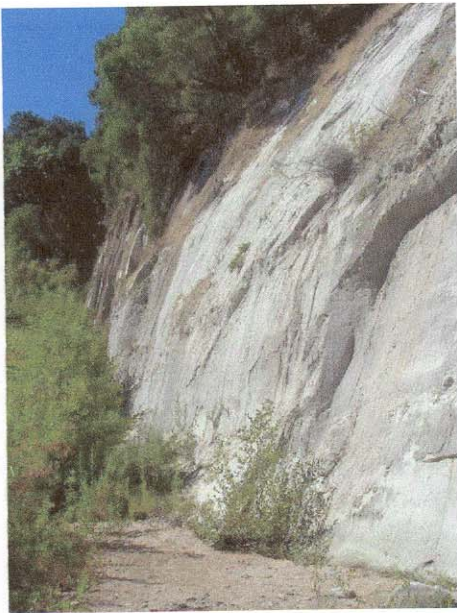
Picture 1

There was some minor bank undercutting and erosion throughout this reach. There is a large sandstone outcrop with a large sediment deposit beneath it (See Picture 1).

#5, 17 There is one significantly fragile sandstone outcrop which has formed an immense point bar with minimal vegetation and caused excessive sediment deposition downstream. There are numerous examples of excessive sedimentation throughout this reach.

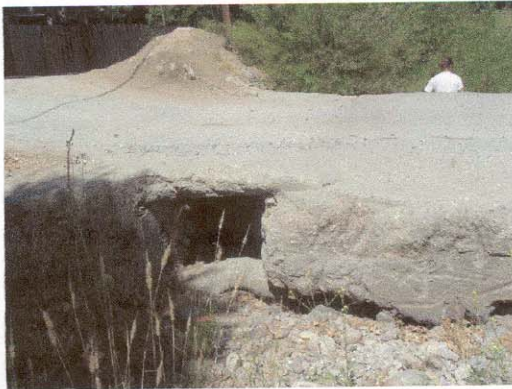
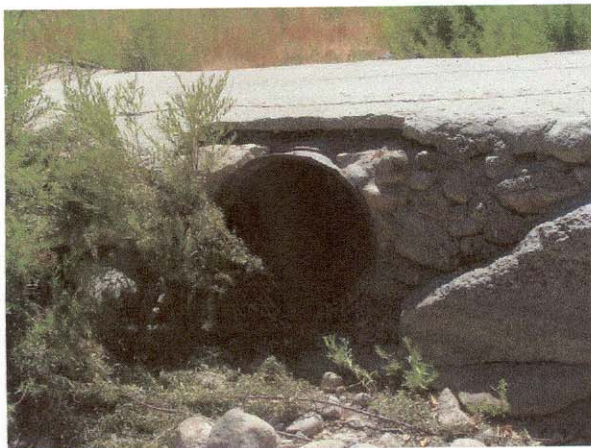
Behind the Cachagua Store there is a concrete ford with two culverts (See Pictures 2 and 3).

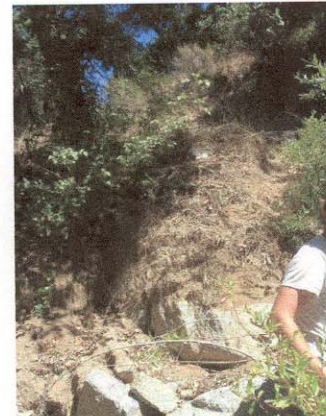
Picture 4

There were a few dirt pushes from the county road into the creek (See Picture 4).

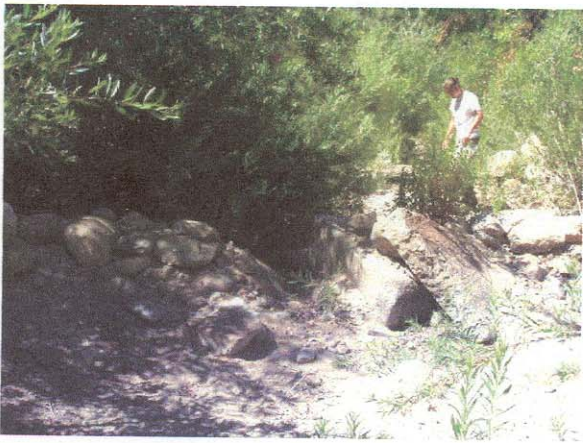
Picture 5

Downstream from the store there is an old summer dam with a landslide nearby (See Picture 5). There are also some buttressed banks that appear to be functioning properly (See Picture 6).
