Standard Checklist

Name of Riparian-Wetland Area: Cachagua Creek

Date: June 23, 2004

Segment/Reach ID: Reach 13

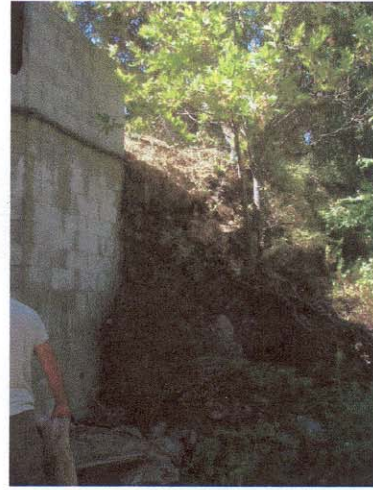
Picture 4

In one place in this reach there is an old well on the north bank that appears to be currently out of service. There is a large concrete foundation and numerous pipes strewn around, some of which have made their way downstream a few hundred feet (See Picture 4).

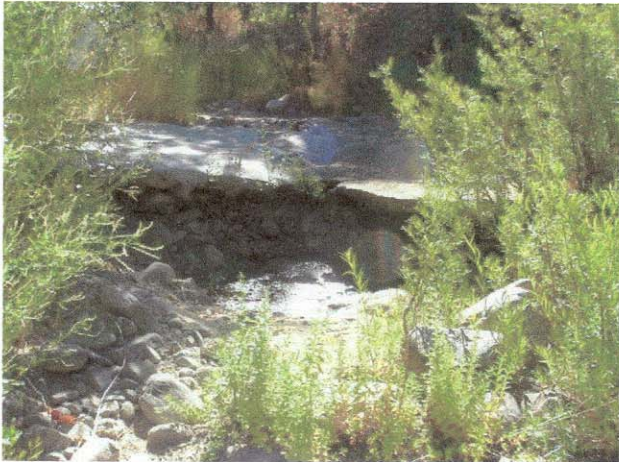
Picture 7

There is a private bridge immediately upstream from county bridge 528 (See Picture 7) that is currently stable.

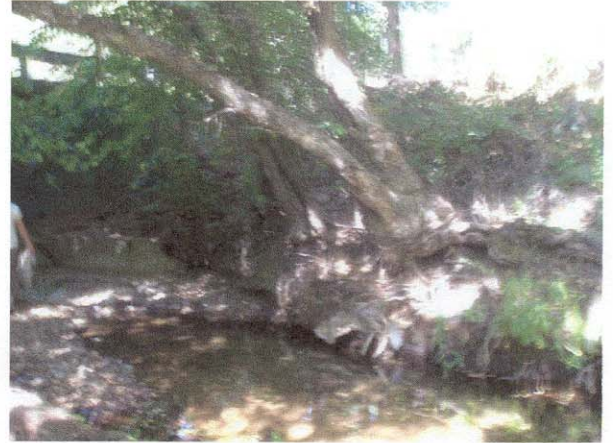
Picture 5

There is a severely undercut old ford which is an impediment to fish migration (See Pictures 5 and 6).

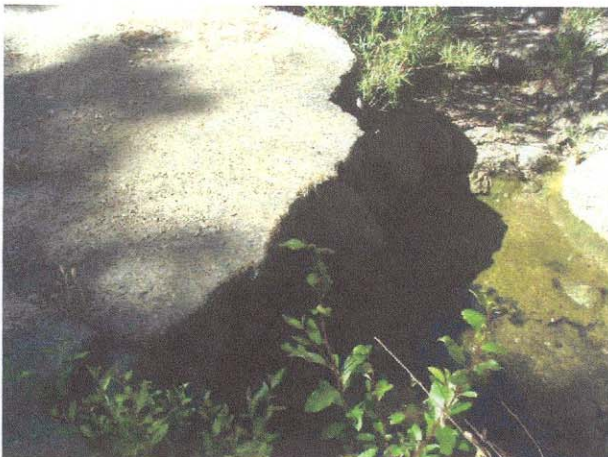
Picture 8

There are some severely undercut banks (See Pictures 8 and 9).
