Standard Checklist

Name of Riparian-Wetland Area: Cachagua Creek

Date: July 9, 2004

Segment/Reach ID: Reach 4

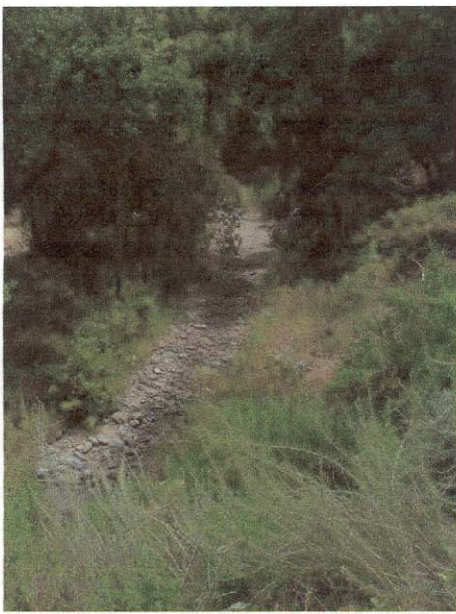
Picture 1

Large sediment deposits were observed throughout the reach. Where large deposits were not present the natural large rock and cobble bed was visible (See Picture 1).

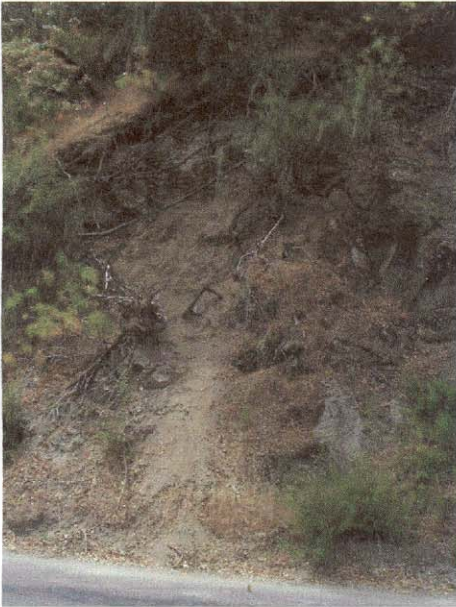
Picture 2

There are a few land slides on the roadside/south bank, that are contributing sediment (See Pictures 2 and 3). One of which was viewed to originate as a creek upland of the road where headcutting is still evident (See Picture 4). Nearby, pieces of asphalt and concrete slabs were observed in the creek bed.

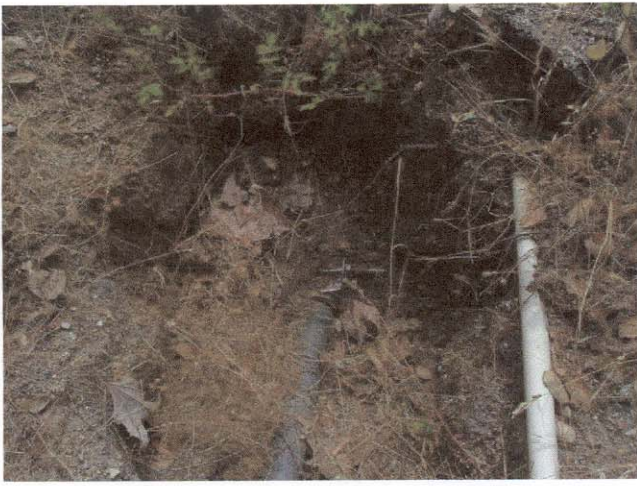
Picture 5

A pump upland from the creek was observed at (See Picture 5)
N 36,23.583 W 121, 36.090
