Standard Checklist

Name of Riparian-Wetland Area: Cachagua Creek

Date: July 6, 2004 Segment/Reach ID: Reach 2 PFC 414

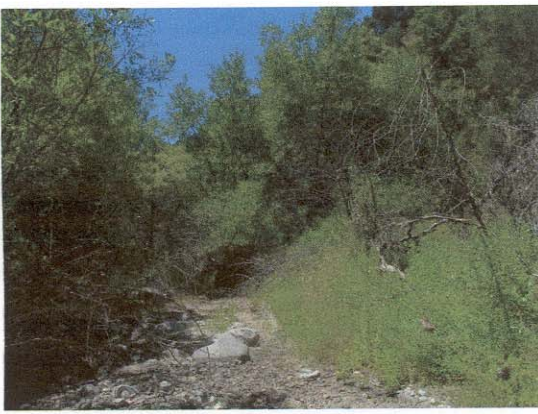
Picture 1

This reach begins parallel to mile marker 10.0. There were many dead alders, uprooted willows and upland species (ie. genesta and a plant from the daisy family) observed in this reach. However there are quite a few willows, and willow recruits present, despite the sparse riparian vegetation and dead alders present (See Picture 1).

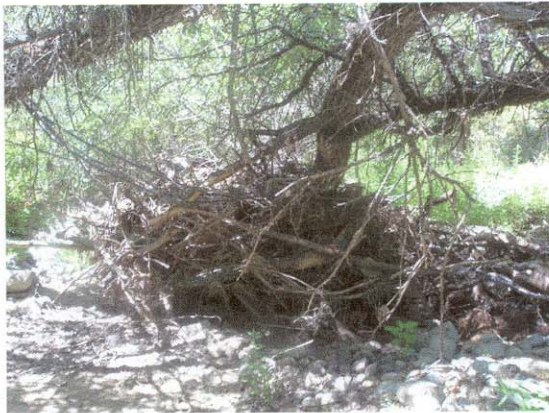
Picture 2

There is one very large log jam that was nearly impassable that may need to be removed (See Picture 2).

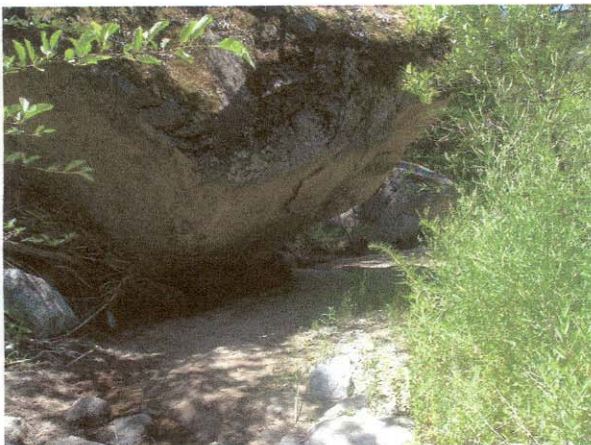
Picture 3

There were several large boulder outcrops with seepage nearby and several steelhead were observed in one of these seepage pools (See Picture 3).
