## Standard Checklist

Name of Riparian-Wetland Area: James Creek

PFC 502

Date: July 5, 2004 Segment/Reach ID: Reach 3

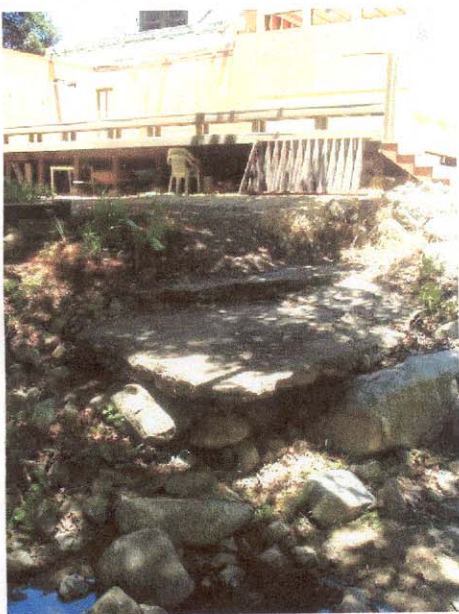
Picture 1

House 38651 was remodeling there are remnants of a concrete foundation fracturing and falling into the creek, a cut down tree and an unstable bank (See Picture 1). There were two other instances on the banks where trees were present but there was a lack of any kind of understory.

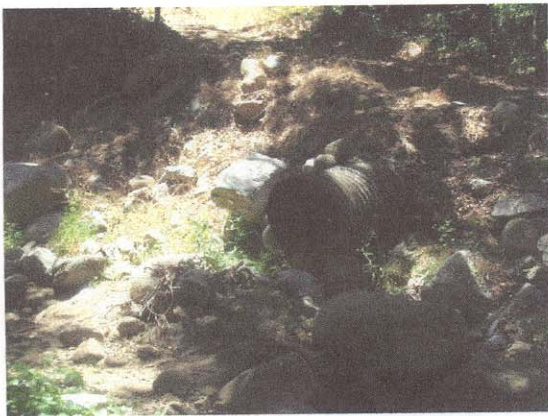
Picture 2

There was one large tributary creek with a large culvert under a driveway at the end of the reach (See Picture 2). There was an old bridge with a gabion under it that is still functioning properly (See Picture 3).
