Standard Checklist

Name of Riparian-Wetland Area: San Clemente Creek (San Clemente Rancho)

Date: May 18, 2004 Segment/Reach ID: Reach 6, Cabin #3 Durbin's PFC 606

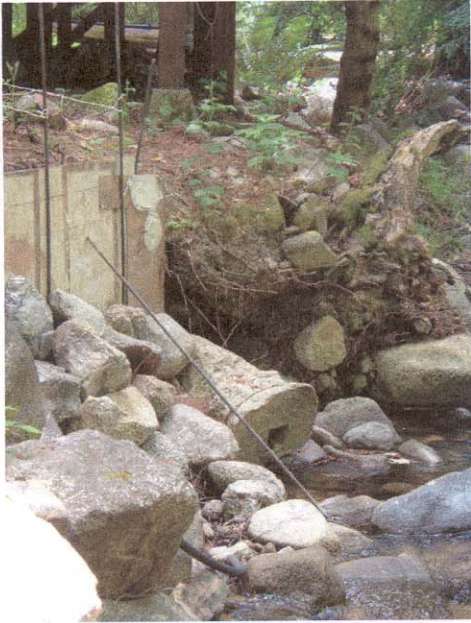
There is an eroding hillside, an eroding bank opposite of the cabin and an eroding bank under the deck of the cabin (See Picture 1 and 2). At the base of the naturally eroding hillside is a grassy floodplain that lacks strong rooted plants. There is a large fallen tree that seems to be helping to catch the dropping sediment and debris and helping to stabilize the base of the hillside. The eroding bank by the cabin has been shored up with rocks and concrete. There is a large point bar forming directly opposite of this concrete structure.

#5, 17 There is excessive sediment in the creek forming a point bar on the bank opposite the cabin. This excess sediment may be from new road and house construction outside of the owners property.

#9, 11, 13 The lack of a large strong root system in the small floodplain across from the house puts the system at risk.

#16 The system is not vertically stable where both banks are eroding and the bank directly behind the cabin is being shored up.
