Standard Checklist

Name of Riparian-Wetland Area: Finch Creek

Date: August 3, 2004 Segment/Reach ID: Reach 9 PFC 706

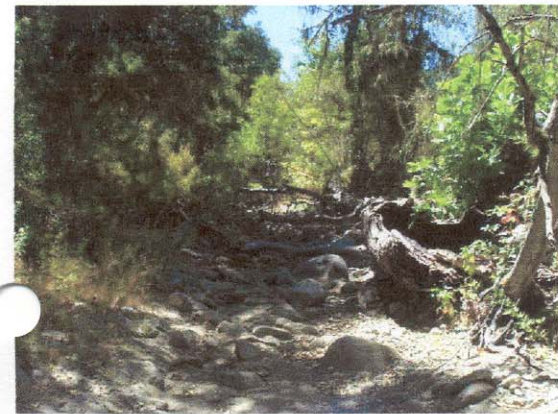
Picture 1

At the beginning of the reach there is a stretch with good canopy recruits and grasses, and seepage is still present, however this stretch is relatively short (See Pictures 1 and 2).

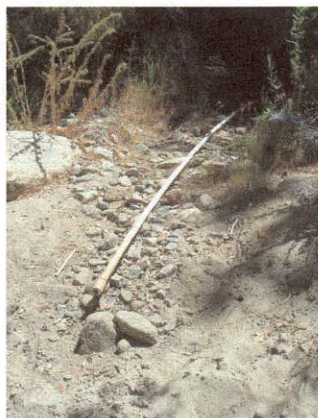
Picture 3

There are lots of upland species, few recruits and several dead alders in the reach (See Picture 3).

#7, 8, 11 There are a lot of upland species present and several dead alders observed. There are minimal recruits in the area.

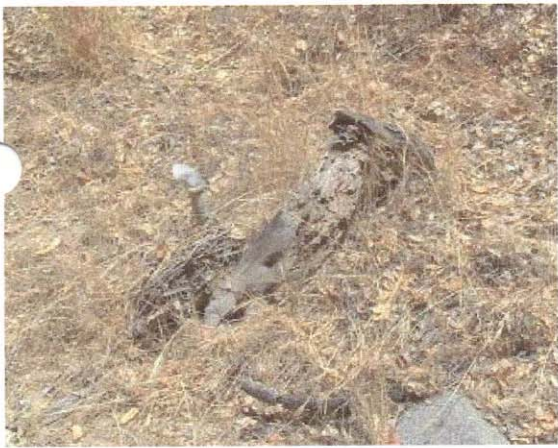
Picture 4

There are two possibly abandoned pipes in the creek, previously used for extracting water (See Pictures 4 and 5).
