Standard Checklist

Name of Riparian-Wetland Area: Finch Creek

Segment/Reach ID: Reach 7

PFC 708

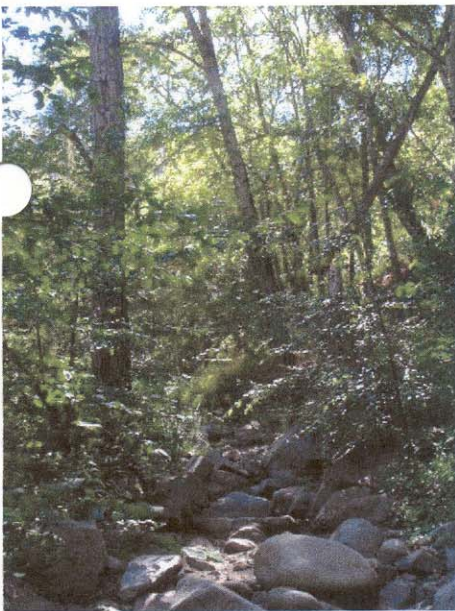
Picture 1

There are three significant overflow channels in this reach. The canopy is very dense with large mature maples, sycamores, buckeyes, alders and willows (See Picture 1). This thick canopy leaves most of the riparian corridor very shaded and few areas with open sky were encountered.

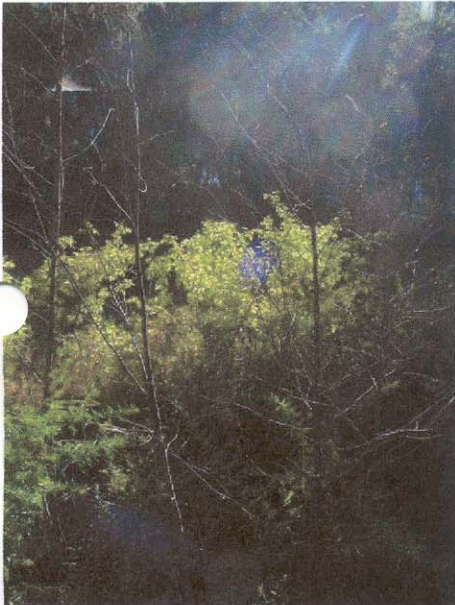
Picture 2

#6-12 There is a strong presence of upland species in this reach and a few dying/dead alders observed (See Picture 2).

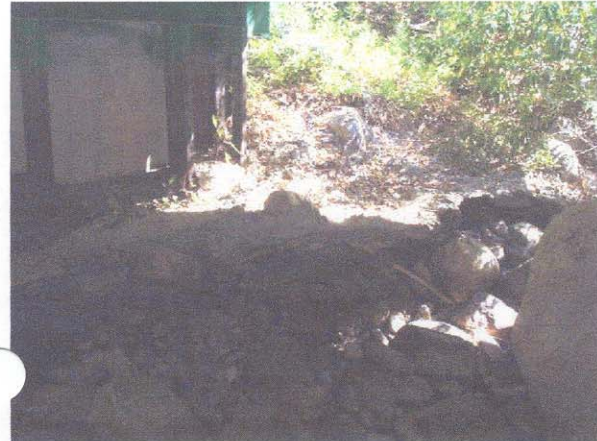
Picture 3

Bridge 539 is undercut (See Picture 3).

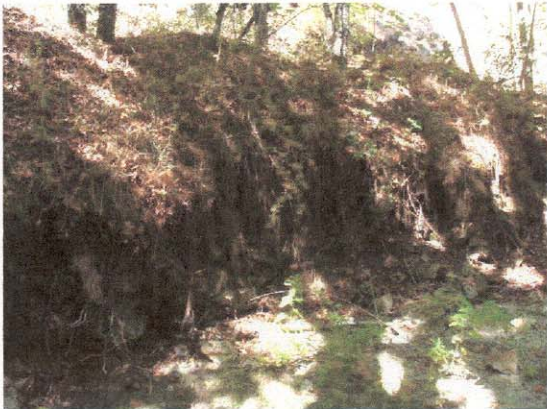
Picture 4

#16 There are a few undercut banks and minor bank erosion (See Picture 4).
