Standard Checklist

Name of Riparian-Wetland Area: Finch Creek

Date: July 27, 2004 Segment/Reach ID: Reach 2 PFC 713

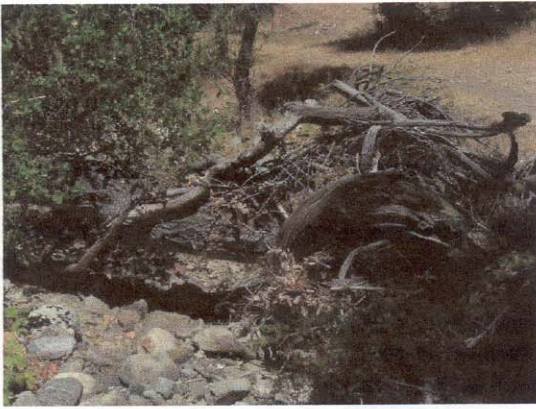
Picture 1

There were multiple log jams, one of particular interest due to its size (See Pictures 1 and 2).

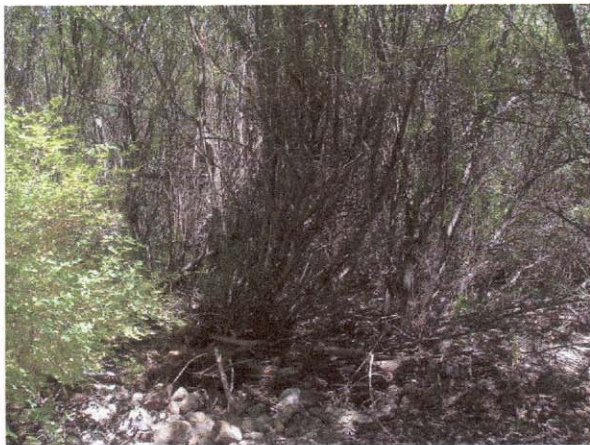
Picture 3

The vegetation in this reach was predominated by mature willows and oaks with little other riparian wetland vegetation. One section in particular was predominated heavily by willows of all sizes, some of which formed a very thick canopy over about 100 yards of the creek (See Picture 3). Some riparian grasses were observed on the floodplain immediately upstream of this stretch. In another area, 10 madrone recruits were witnessed growing in the creek bed. (See Picture 4).
