## Standard Checklist

Name of Riparian-Wetland Area: Tularcitos Creek

Date: August 27, 2004

Segment/Reach ID: Reach 5

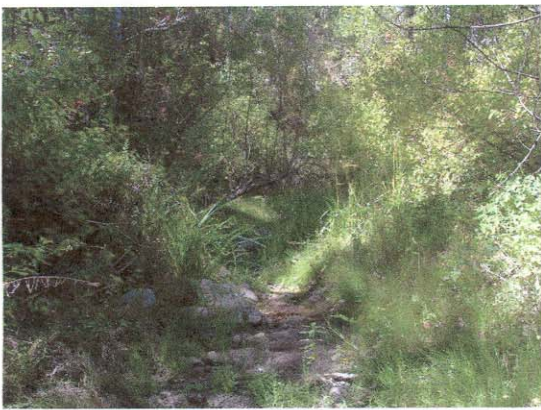
Picture 1

This reach begins at power pole 488 on Carmel Valley Road. The riparian habitat throughout this reach is very lush. There is a diversity of large mature trees: Laurels, Alders, Sycamores, Cottonwoods, Buckeyes, Willows and their recruits. There is plenty of poison oak, and blackberries to serve as a ground cover. This reach had no urban influence on it. (See Pictures 1, 2 and 6)

The beginning of the reach was wet with seepage, there is a strong presence of sedges and grasses (See Picture 1). The majority of the reach was dry. There are plenty of rocks, cobbles and gravels for good spawning habitat (See Picture 2).

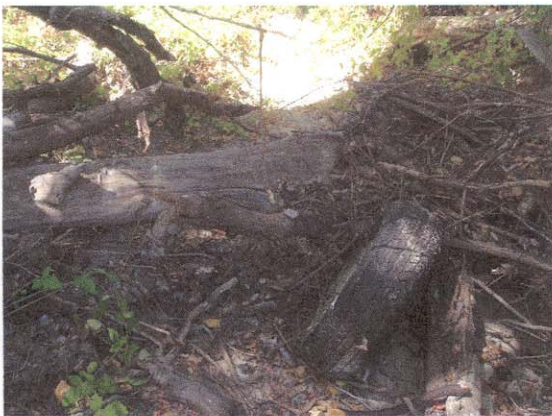
Picture 3

Several large logjams were encountered, evidencing both the presence of LWD and its sources (See Pictures 3, 4 and 9). There are several accessible floodplains that aid in dissipating energy.

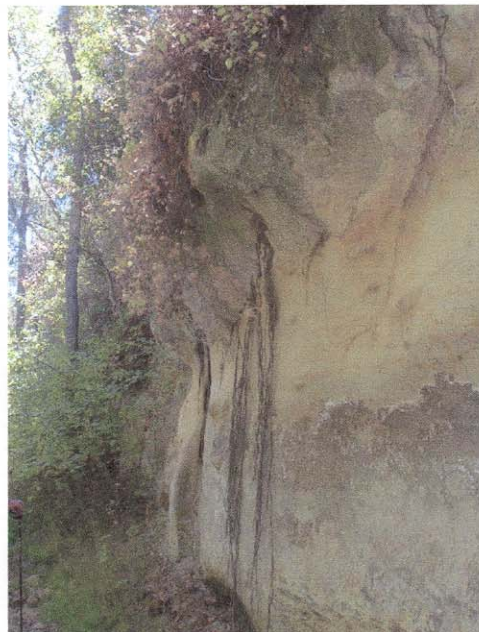
Picture 5

There are a few large sandstone outcrops that are naturally eroding (See Pictures 5, 6 and 7).

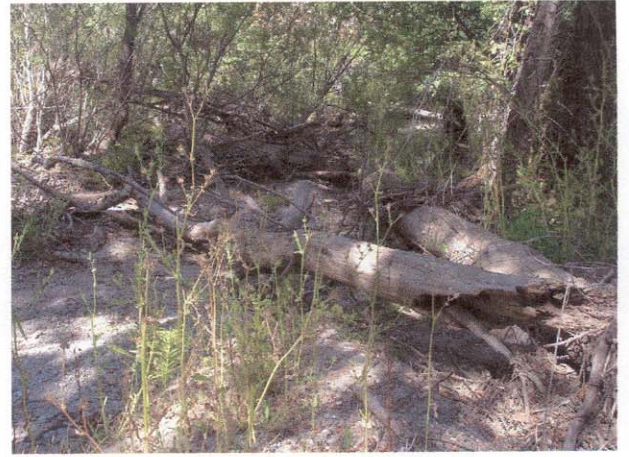
Picture 9

This reach ended at the Confluence with the Carmel River (See Picture 9) at N36, 27.922 W121, 42.873. (The river was cloudy from turbidity)

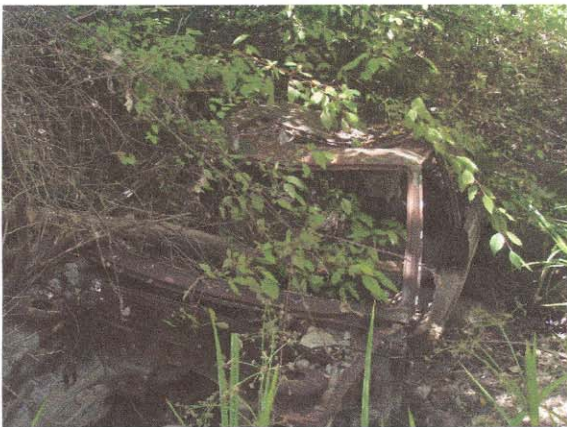
Picture 8

There are two old cars in the creek bed (See Picture 8).
