## Standard Checklist

Name of Riparian-Wetland Area: San Jose Creek

Date: August 25, 2004 Segment/Reach ID: Reach 1 PFC 952

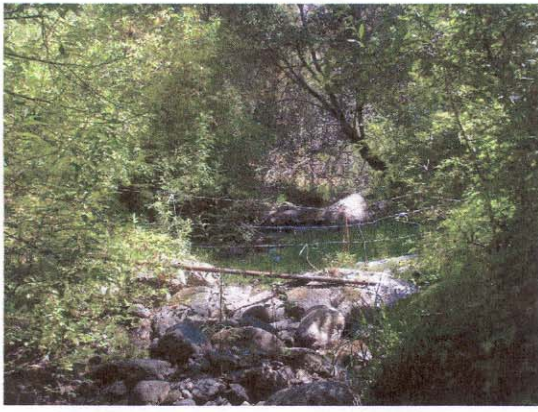
Picture 1

This reach begins at the Fence of Riley Ranch of N 36, 31.110 W 121, 54.527. Just beyond the fence, a well was observed in the creek bed whether it was operating could not be deciphered (See Pictures 1 and 2).

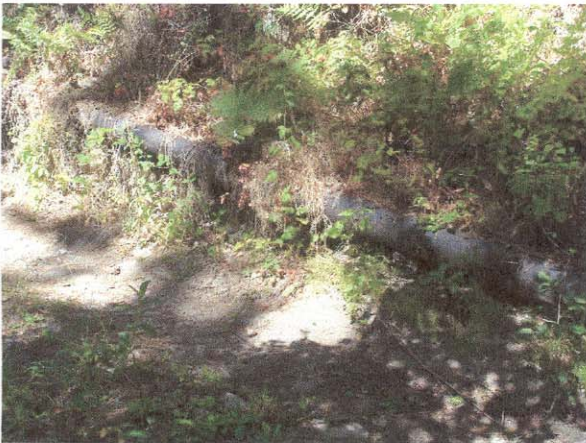
Picture 3

There was a large iron pipe that ran along side the creek throughout the first reach. It was first observed by the dirt ford in front of the Riley Ranch gate and continued to N 36, 31.131 W121.55.188. (See Picture 3).

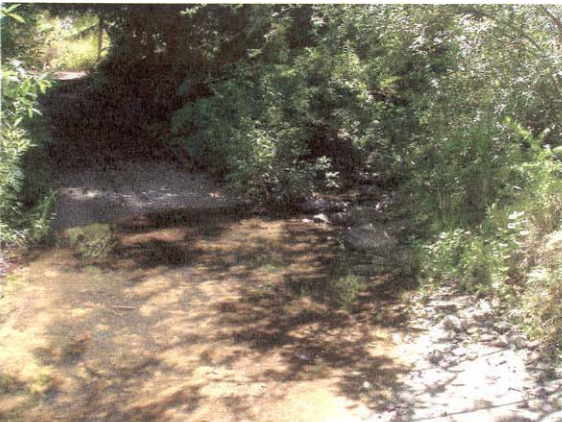
Picture 4

There are two dirt fords in this reach that are functioning properly (See Picture 4).

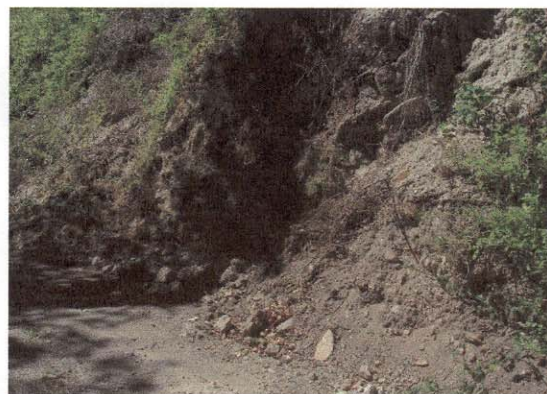
Picture 5

There are four tributaries running off the upland hillside by the road cut. There was a pool with tadpoles found on the road cut at the base of one of these tributaries. The uplands by this road cut are eroding and several landslides were observed. It is apparent that this is a common problem which is systematically monitored (See Pictures 5 and 6).

#5 There are several instances of slides and eroding hillsides due to the road cut.

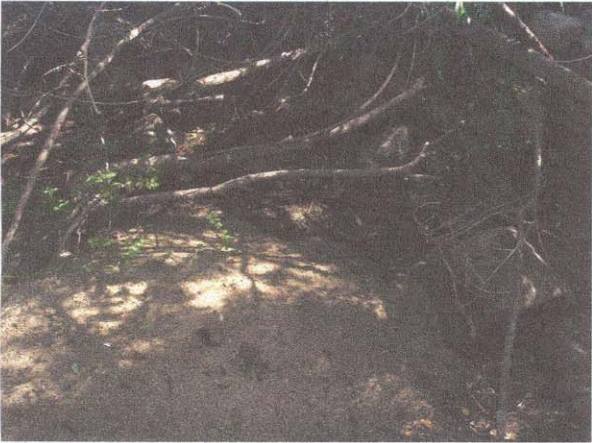
Picture 7

The vegetation is dense, vigorous and extremely diverse. There is sediment visible throughout the creek however, it did not seem excessive. There are large boulders and rocks in the creek, but many cobbles (See Picture 7).

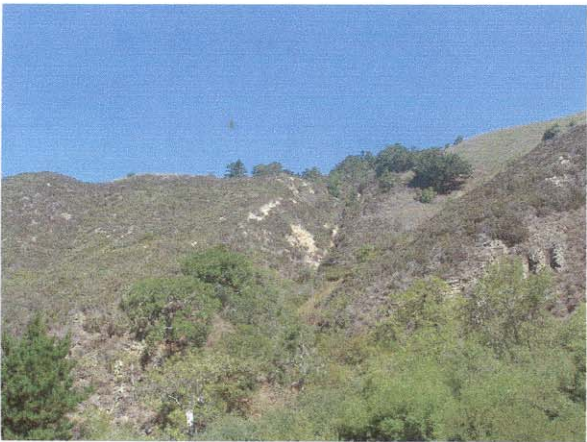
Picture 8

There are a few naturally eroding and recovering uplands on the north side of the creek (See Picture 8).
