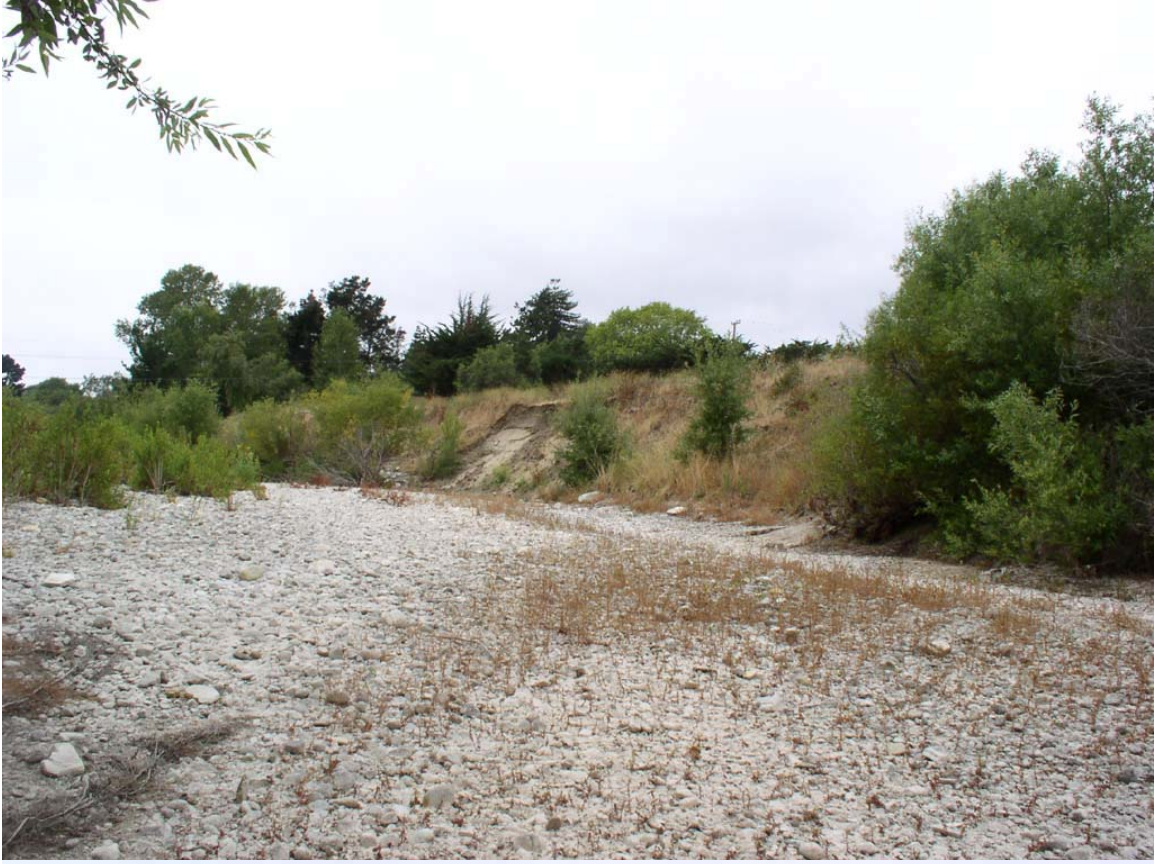
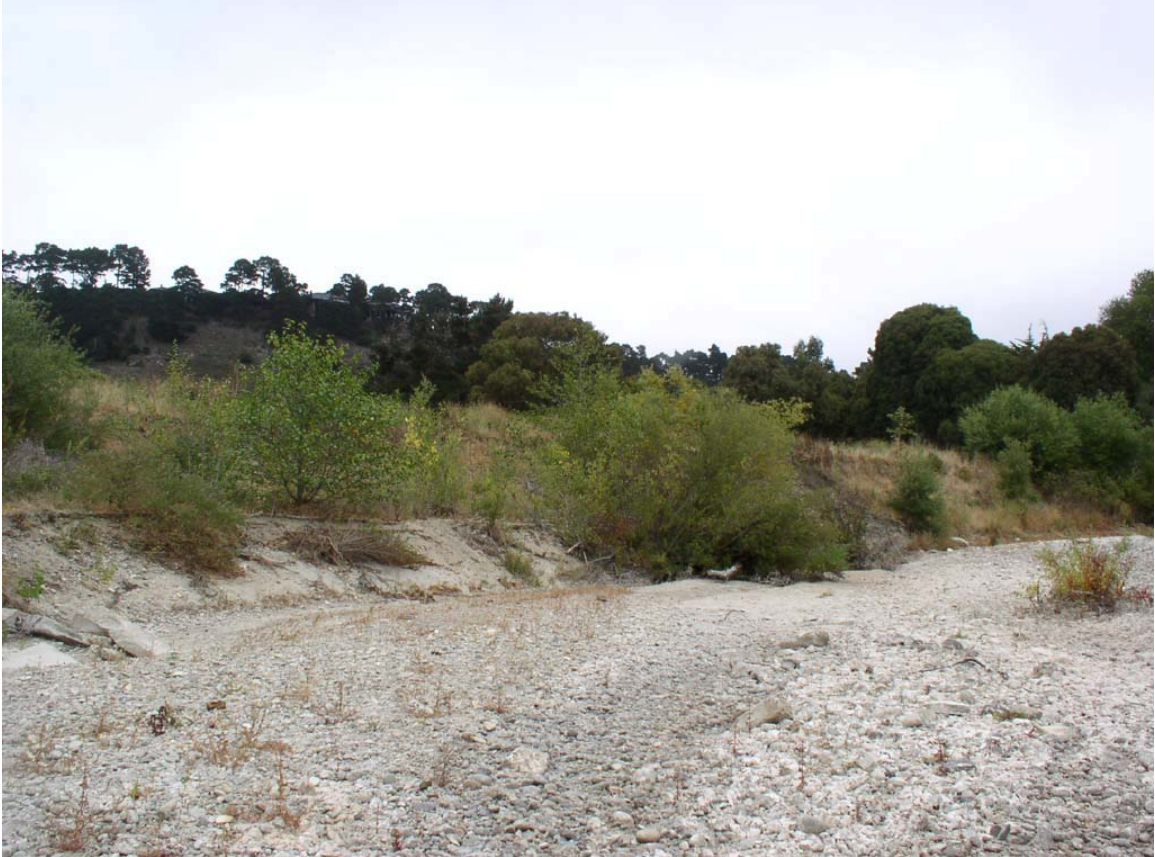
North bank heavily eroded with no vegetation to protect it. Heavy groundwater extraction in the area is affecting vegetation recruitment and vigor.

Proper Functioning Condition	___
Functional – At Risk	___
Nonfunctional	<u><u>X</u></u>
Unknown	___

Upward	___
Downward	<u><u>X</u></u>
Not Apparent	___

<input type="checkbox"/> Flow regulations	<input type="checkbox"/> Mining activities	<input type="checkbox"/> Upstream channel conditions
<input type="checkbox"/> Channelization	<input type="checkbox"/> Road encroachment	<input type="checkbox"/> Oil field water discharge
<input type="checkbox"/> Augmented flows	<input checked="" type="checkbox"/> Other (specify) Groundwater extraction
