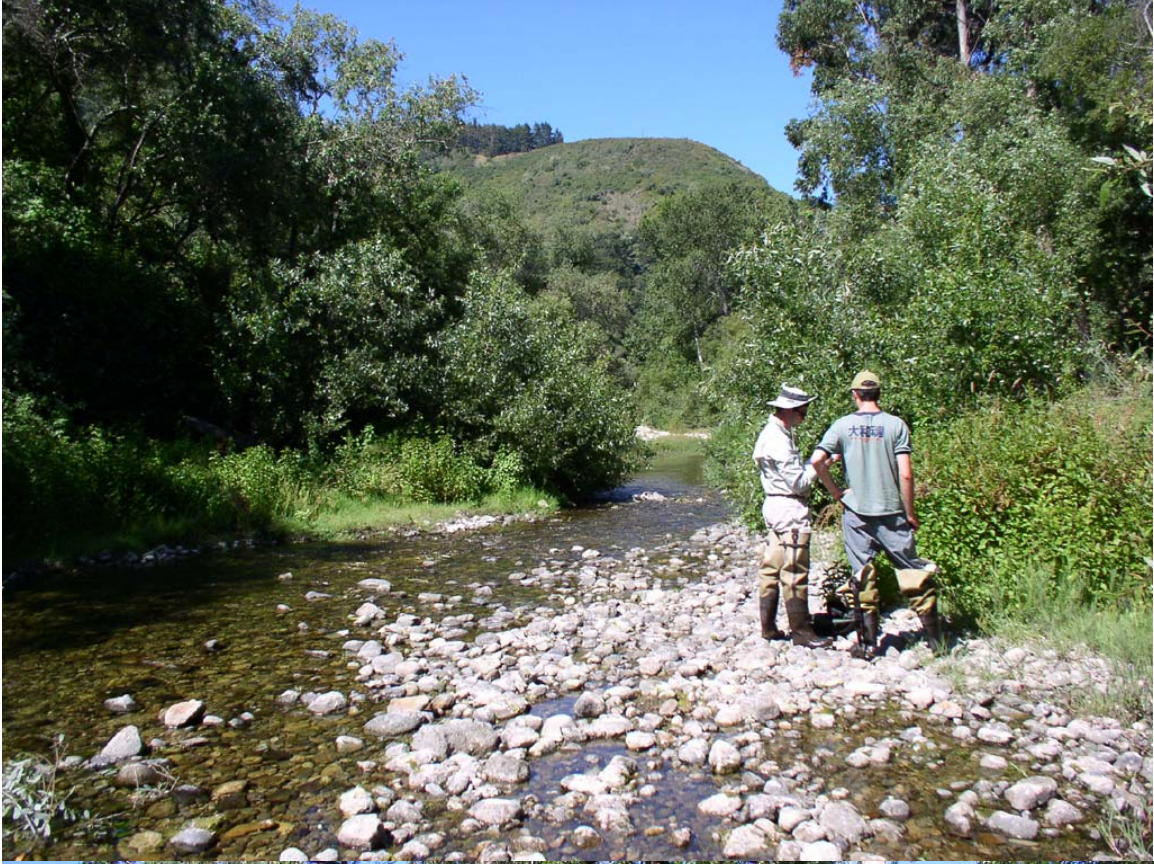
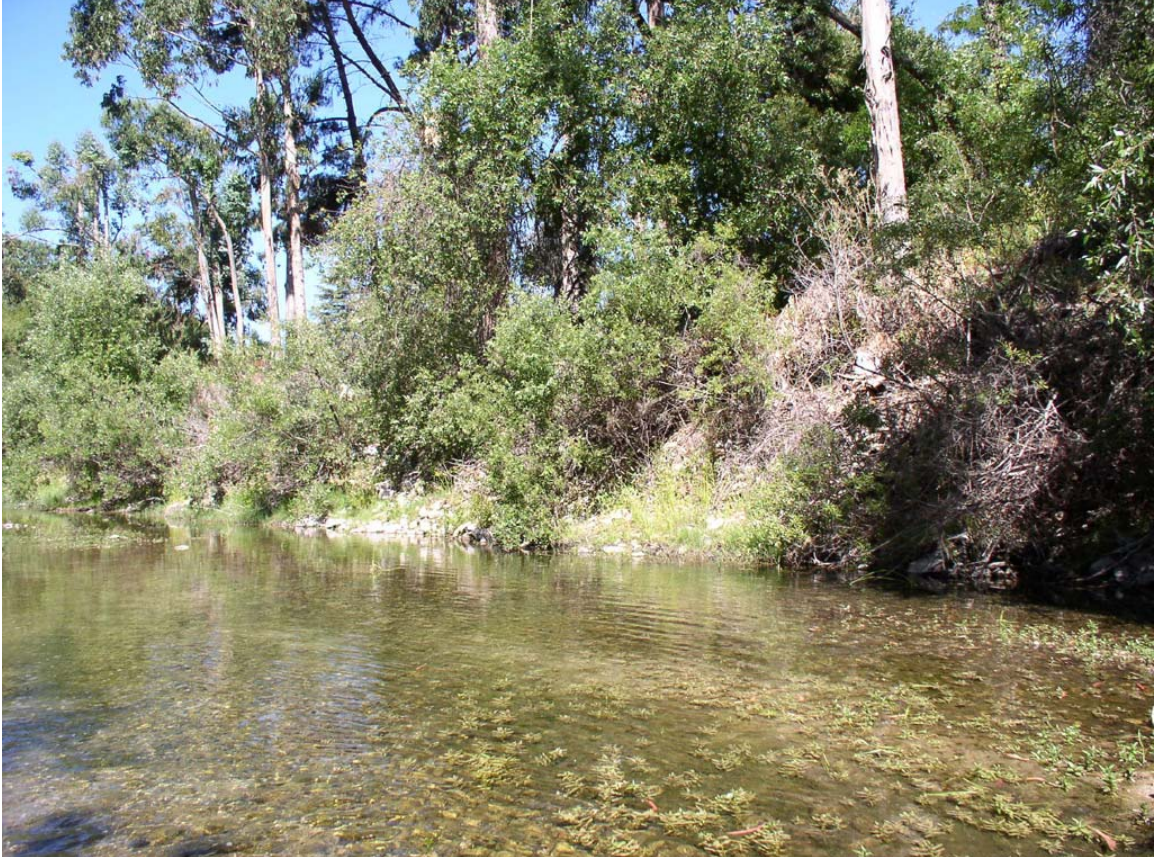
Primary riparian vegetation includes: black cottonwoods, red and arroyo willows, white alders, and western sycamore. This section received a functional at risk rating because there was a thin band of riparian vegetation that could fail in a high flow.

This area is also impacted by groundwater extraction by Cal-Am's Pierce Well.
