## Standard Checklist

Name of Riparian – Wetland Area: Carmel River Watershed – Garland Park Area

Date: 6/3/04      Segment/Reach ID: 15-Carmel River 600 feet downstream of  
Randazzo’s Bridge

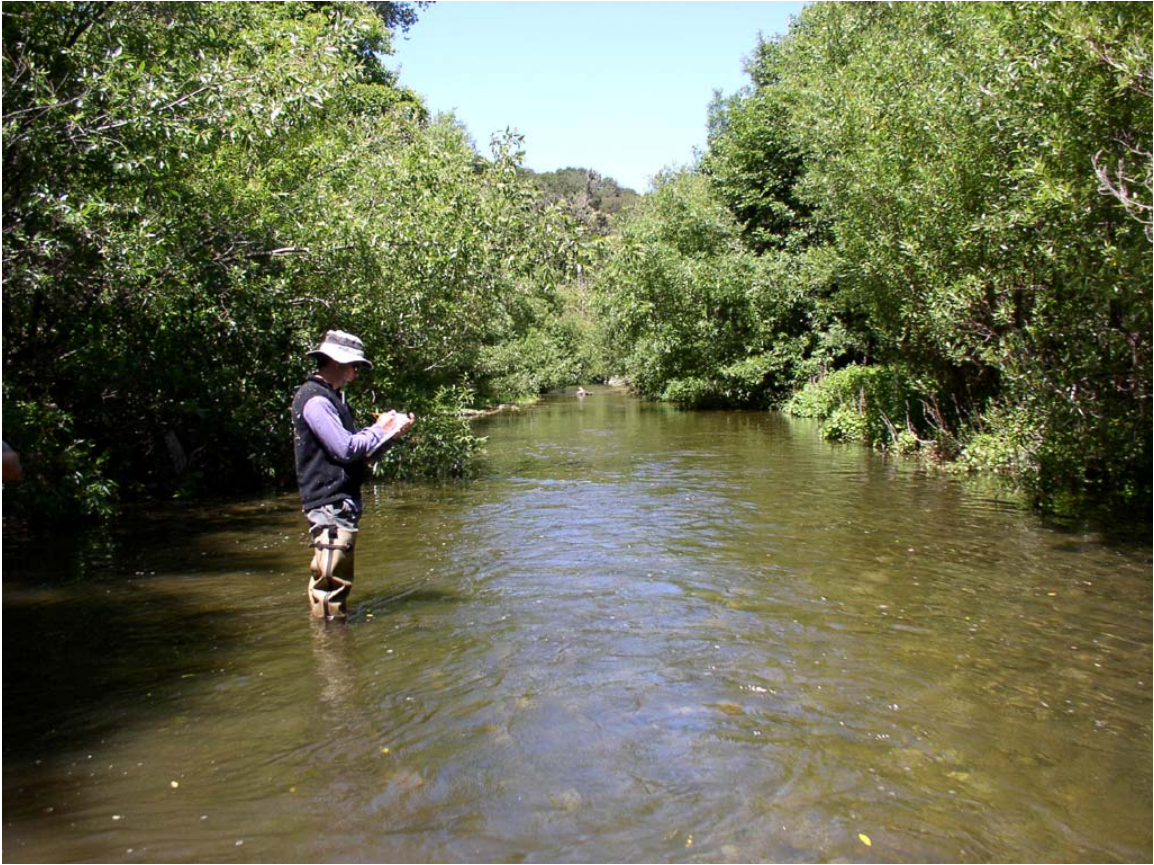
Primary riparian vegetation includes: black cottonwood, red and arroyo willow, white alder, and western sycamore. Many bullfrogs were observed in this reach. The banks in this reach are hardened with concrete rubble.
