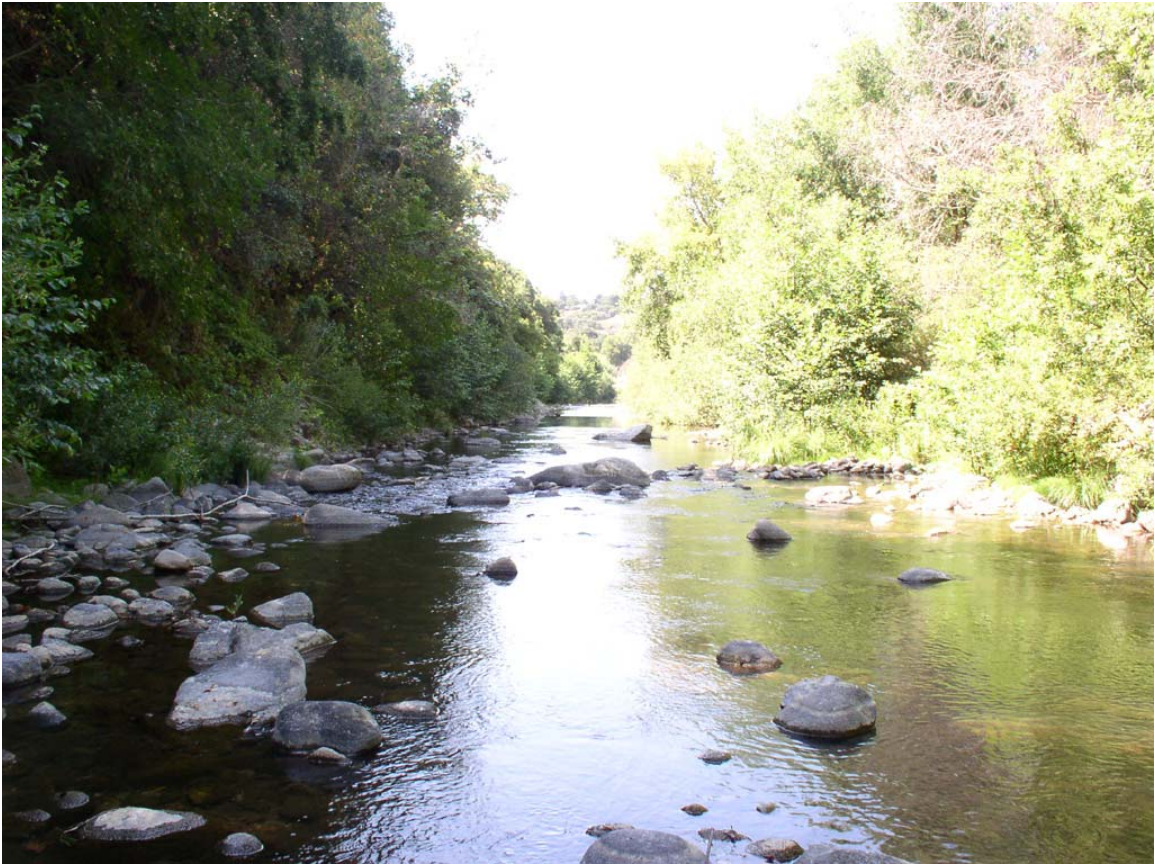
Lots of large size class boulders, cobble, and bedrock outcrops to dissipate energy. Riparian species include white alder, Santa Barbara sedge, red and arroyo willows, black cottonwoods, and western sycamore. Residential houses are encroaching on the riparian area.
