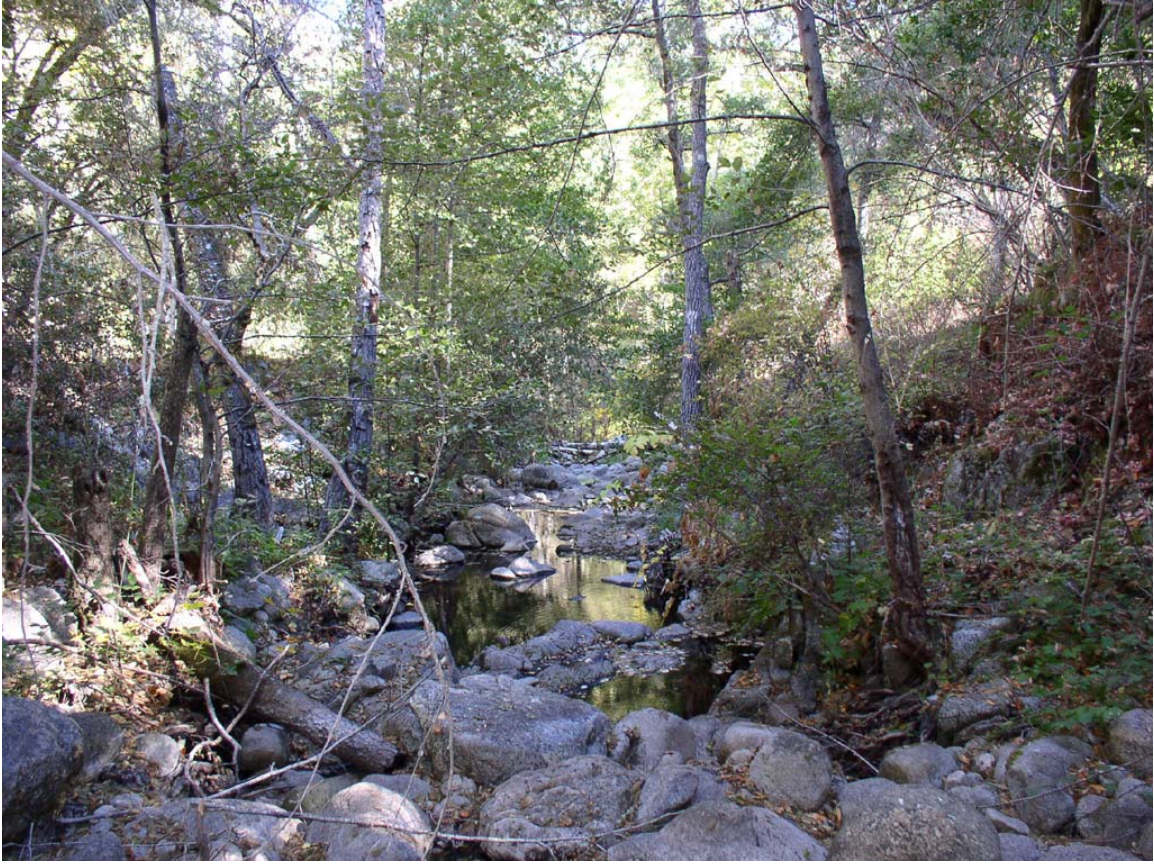
Canyon controlled channel with large class boulders and angular rock. There are some miniature bank full floodplain areas, but they are limited in size. Primary riparian vegetation includes: willows, white alders, Santa Barbara sedge, and western sycamore.

Proper Functioning Condition	<u> X </u>
Functional – At Risk	<u> </u>
Nonfunctional	<u> </u>
Unknown	<u> </u>
