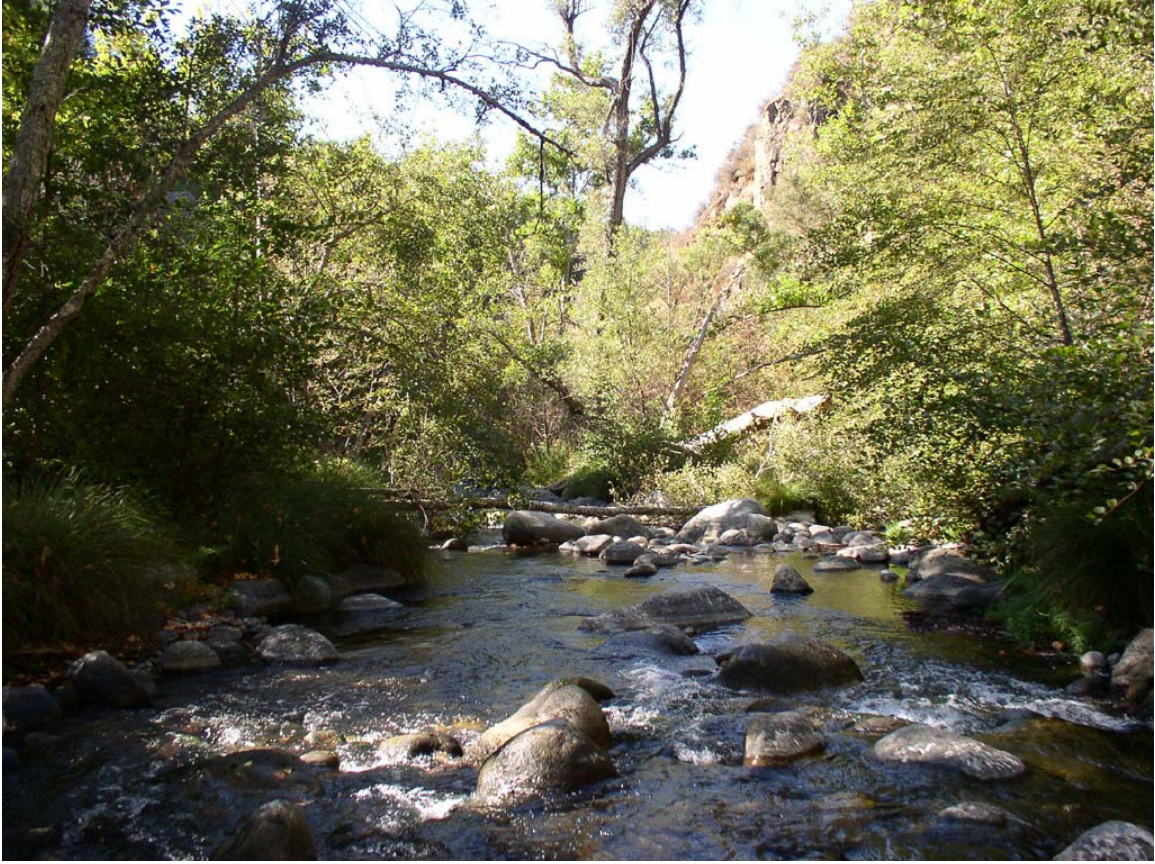
Canyon controlled channel with large class boulders and angular rock. Primary riparian vegetation includes: willows, white alders, Santa Barbara sedge, and western sycamore.
